studio
Berlucchi
società di ingegneria
dal 1920

THE TOWN HALL BUILDING IN SAN BENEDETTO PO (MN)

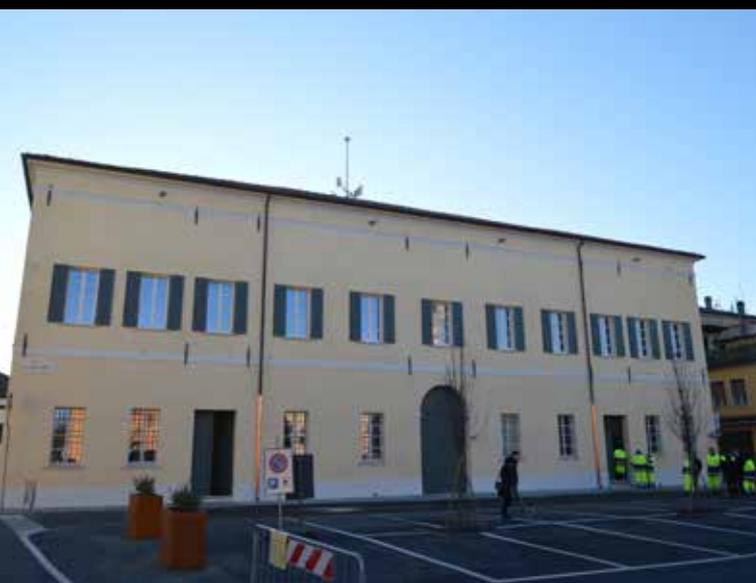
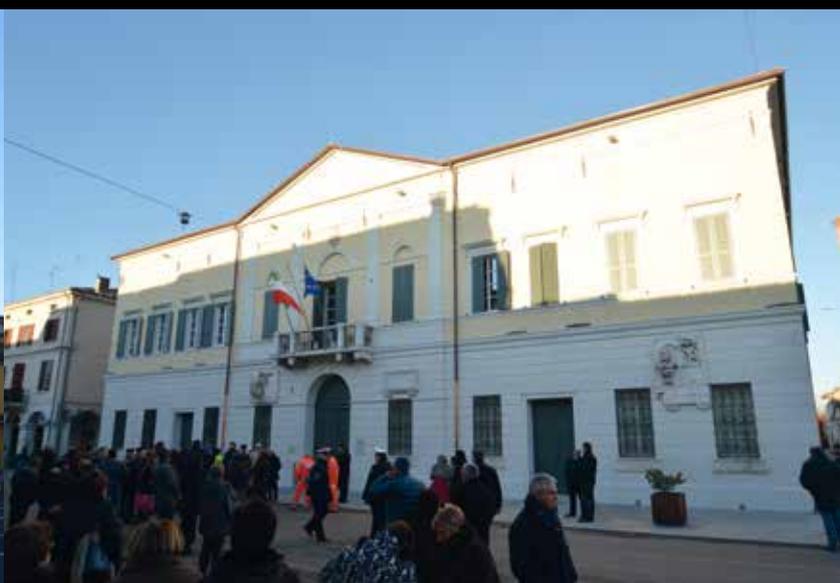
The Town Hall of San Benedetto Po is a typical nineteenth-century structure based on solid brick masonry, which has been the object of several modifications over time. These alterations turned the building into a complex and seismically vulnerable structure: during the history of the building, some local rigid reinforcements, brick and concrete floors were added, and the internal functional layout was changed. An earthquake in 2012 caused huge damage to the structure, which imposed urgent restoration works in the entire complex.

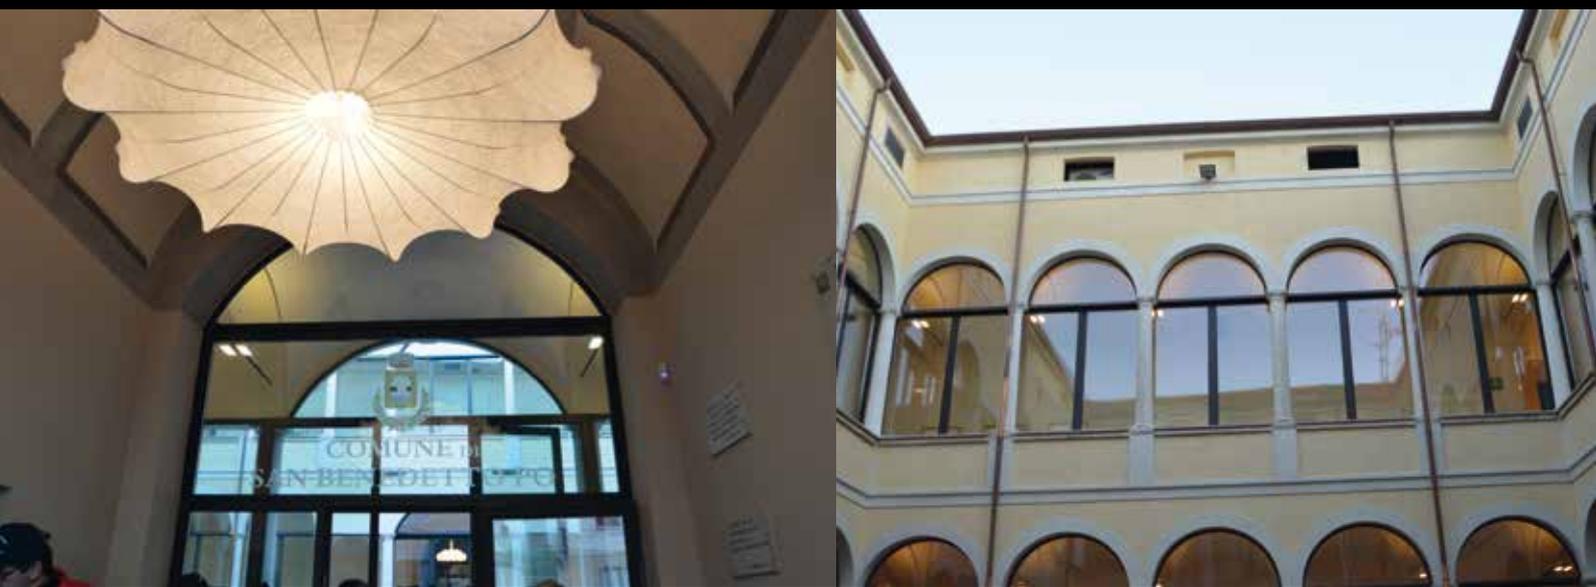
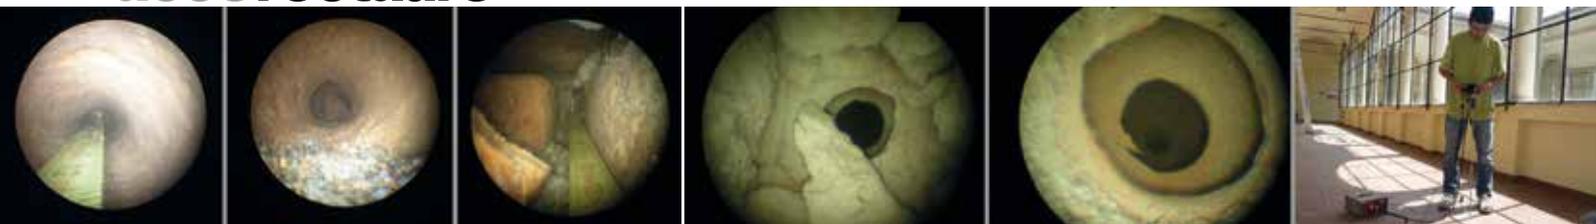
A historical structure does not usually offer good box action, which makes it more vulnerable to damage owed to the separation between different structural elements. A modeling of the building makes a basis to make hypotheses and reckon the reaction to seismic stress mathematically.

The execution of a 3-D mathematical model of finite elements is implemented with a number of possible solutions capable of preserving most of the original structure and, if

required, adding some elements. The works executed in the Town Hall included the following solutions, among others:

- introduction of horizontal metal chains across the building, at the vault extrados (areas were emptied to make room for the works);
- construction of reinforced plaster wall. Clearly, the latter solution will not be viable in valuable historical buildings, but here the 3-D study of box action was intersected with the practical need to accommodate the offices in spaces of poor historical value. The benefits of the solution lie in user-friendly and cost-effective works, which were carried out in the new added elements only.
