Eng. Nicola Berlucchi
 Eng. Stefano De Vito

■ The reparation and the seismic strengthening of the Monastery of “San Benedetto in Polirone”

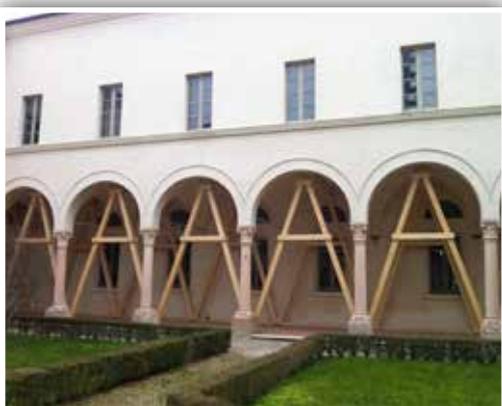
The provisional reinforcement of the arches in the "Secolari" cloister

The arches in the "Secolari" cloister and the main entrance of the museum were reinforced with wooden provisional structures specially designed to maximize their efficiency in accordance with the context. The lightweight decorated ceiling of the "monumental stair" and of the "Monastic Library" were protected and sustained with dedicated punctual scaffoldings. The "Ala Giorgi" – already structurally unstable before the quake – needed to be strengthened with provisional nylon cables, wooden trusses and local supports of arches and doors.

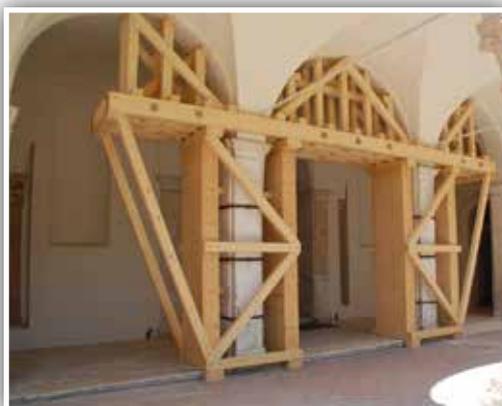
The provisional reinforcement of the columns of the main entrance of the museum in the "Secolari" cloister

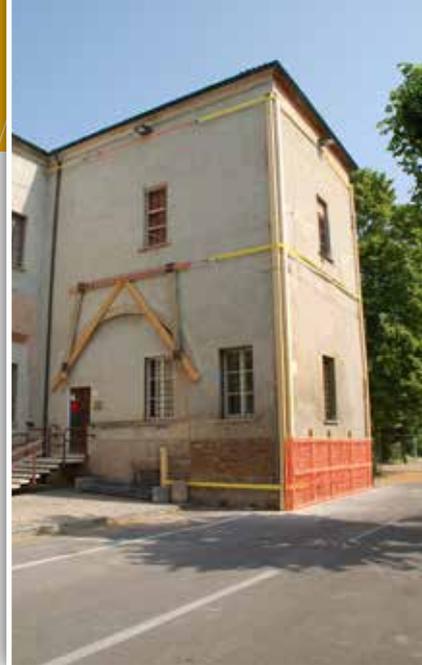
The provisional strengthening of the "Ala Giorgi"

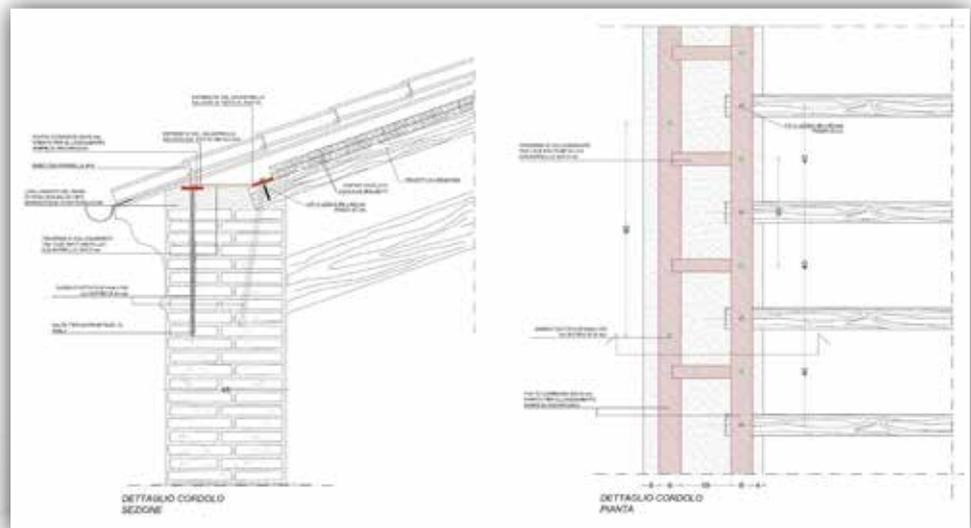
Technical detail of the interventions on the top of the perimetral walls.

structural weaknesses. The roof was the weakest portion in consideration of the lack of connections among each structural element and was the only area without decorated plasters. The wooden structure was completely restored with metallic reinforcements and with the insertion of new dedicated metal-ties. Such interventions were necessary to connect the perimetral walls with each other and with the wooden trusses of the roof. After these works, the roof was refurbished and completed with thermal insulation, a new waterproof layer and the reallocation of roof tiles in accordance with the surroundings.

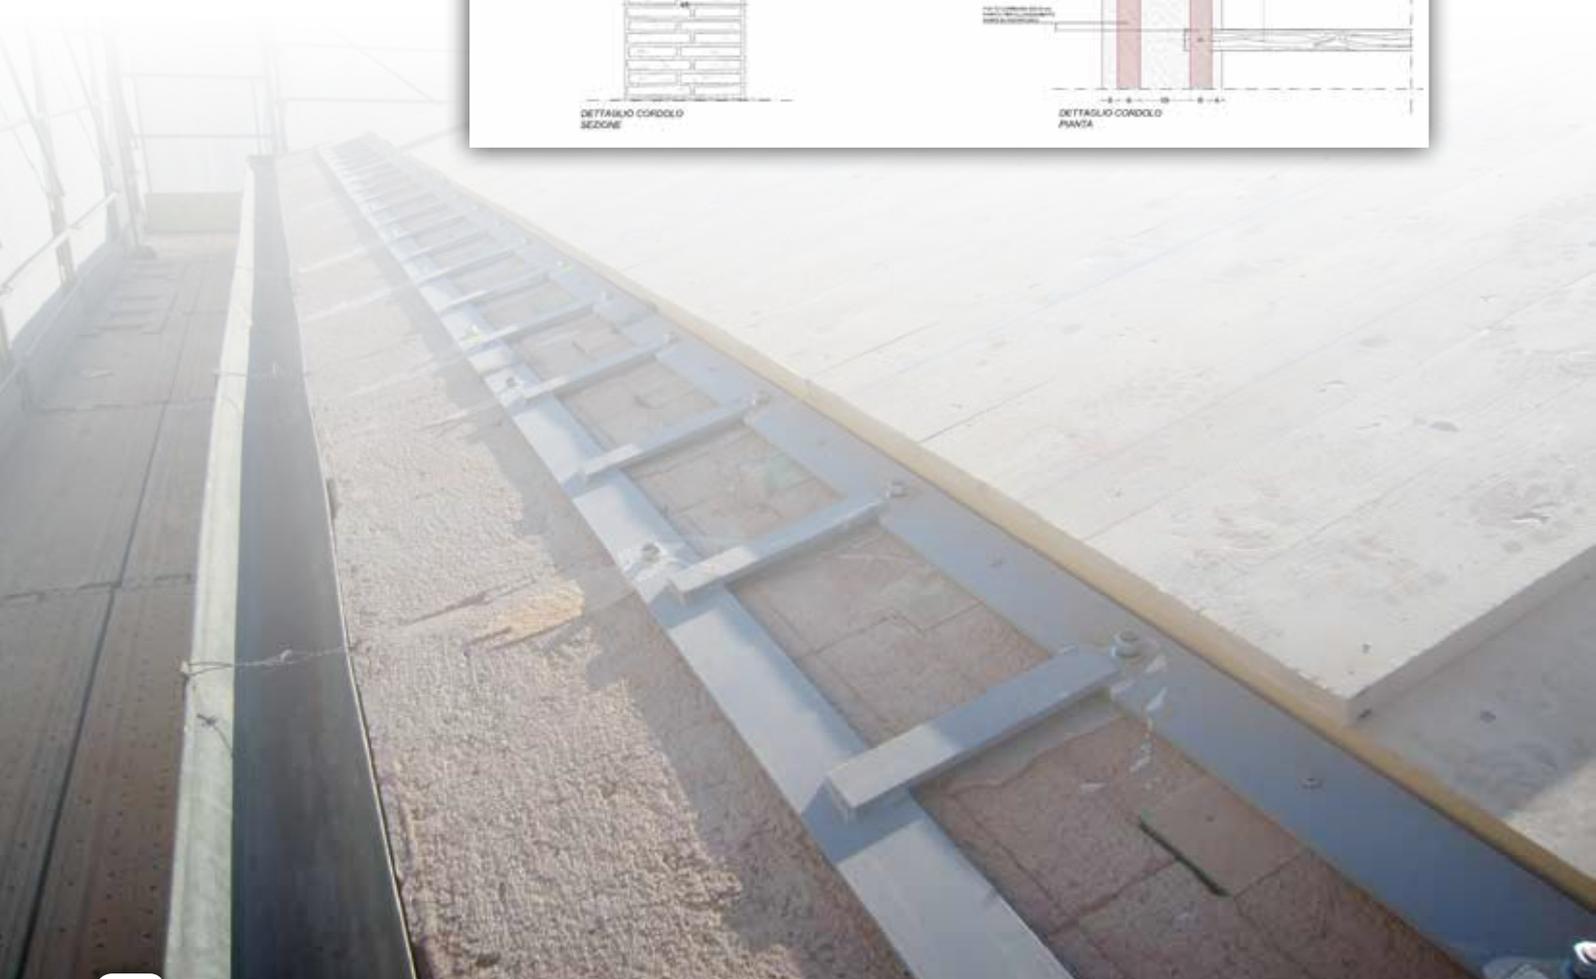
The interventions on the top of the perimetral walls.

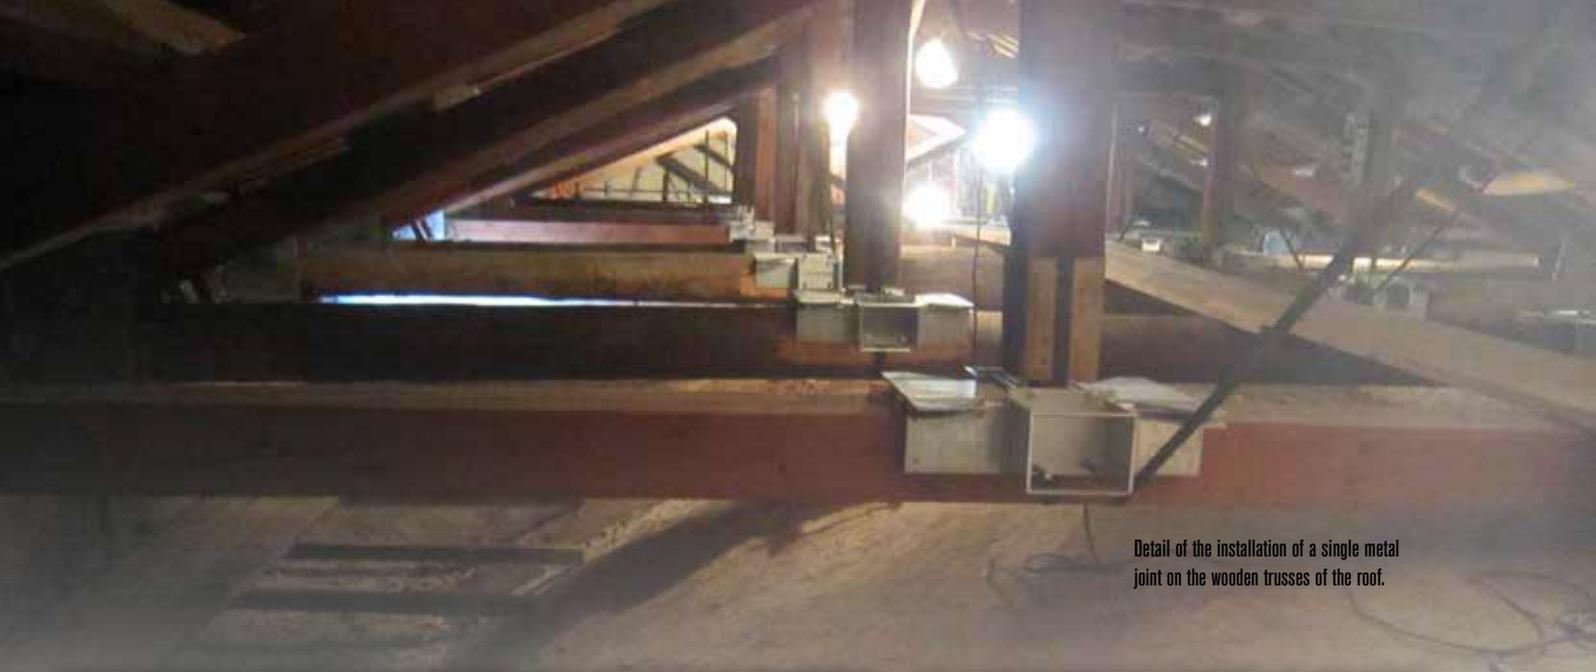
Detail of the installation of a single metal joint on the wooden trusses of the roof.

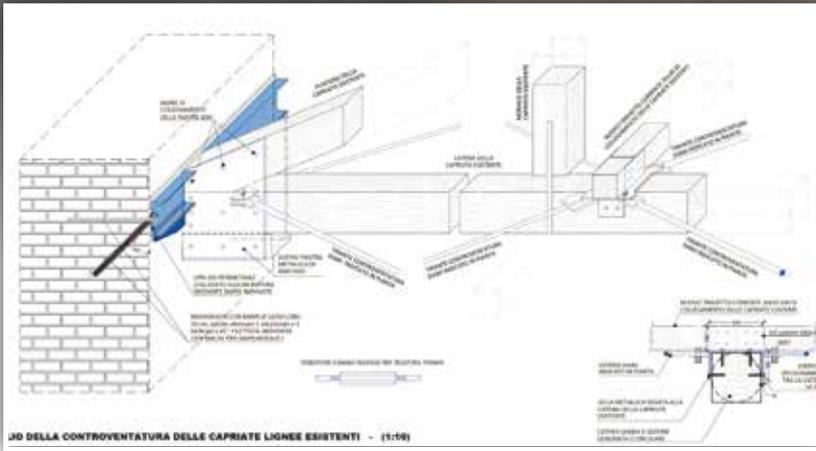
Project detail of the strengthening system

The building of the “Refettorio” is a large and empty room composed of four spans with cross vaults each almost 15 meters wide. The first cross vault collapsed almost a century ago, while the remaining three resisted even the earthquake. The survived vaults exposed large and dangerous cracks after the quakes, mostly concentrated in the perimetral portion, inducing to fear the possibility of their collapse. Such vaults were realized with a heavy double layer of bricks, and after an accurate analysis were considered stable. The problem was identified in the perimetral walls that needed to be better connected mainly in the top area. The intervention proposed start off from the reparation of the cracks in the vaults with appropriate injections and on the reinforcement of the horizontal connection among perimetral walls. Such connection will be realized thanks to a new wood and metal structure. A new metal ring made with UPN 200 will be connected with the existing walls just under the roof, and a series of new metal joints will be applied between the existing trusses and the metal ring. Each joint will be connected with metal cross-braces in order to set several smaller spans among the original larger ones. The principle of the intervention is quite simple and is based on the idea that smaller spans have a much better behavior than larger ones in case of earthquakes.

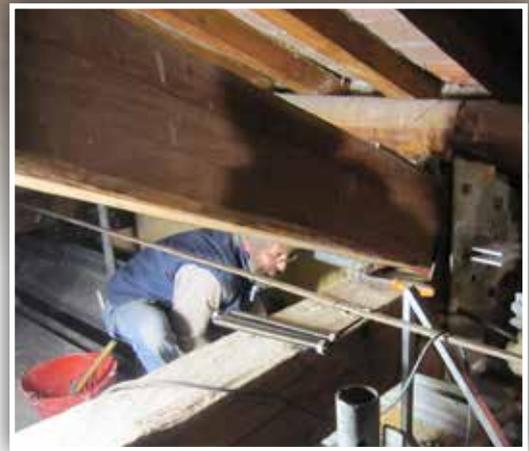
General view of the roof of the Refettorio during the implementation of the work

The simplicity of the principle didn't actually follow the realization; in fact every existing wooden element was different from each other and differed in height, size, position and state of preservation. Every single joint needed to be verified, controlled and often adapted to meet the specifications requested. In many cases the structures were modified and adapted during the history and offered different dimensional configurations. Moreover, the area of intervention (between the roof and the vaults and among the existing trusses) was particularly difficult and uncomfortable because of the small operative spaces, the lack of light and the sloping floor. Many unexpected chances occurred during the development of the work, but finally the strengthening system was completed.

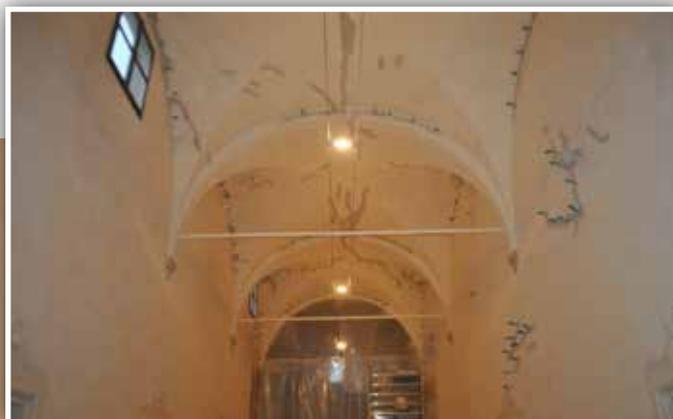
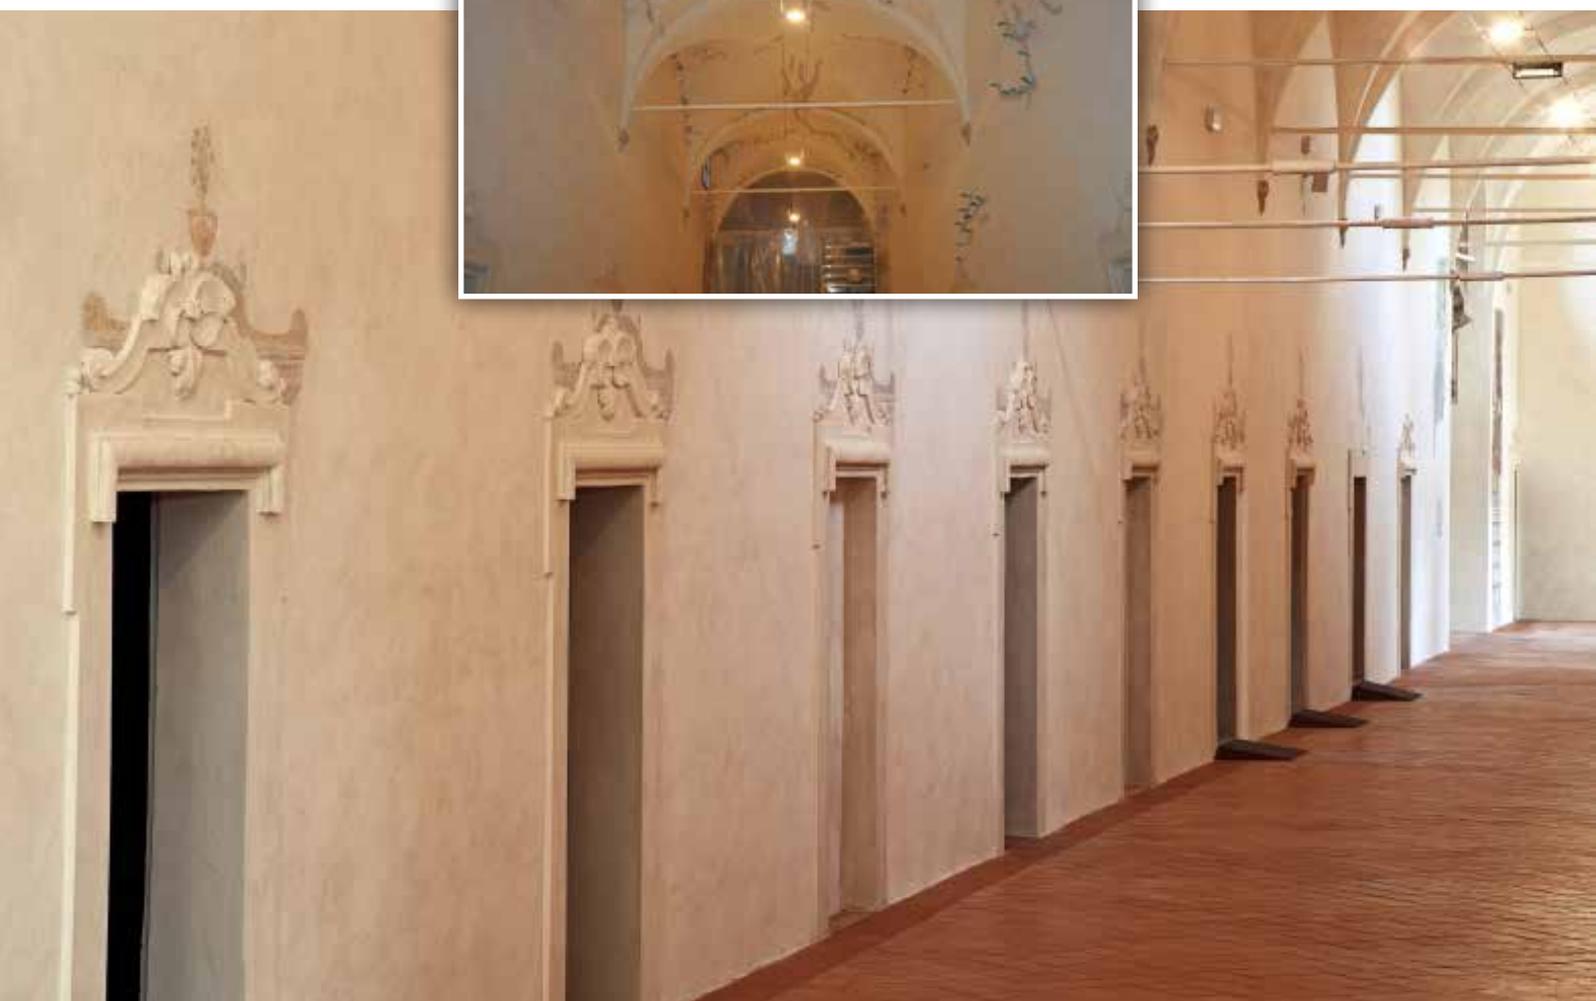
The reparation of the cracks with mortar injections during and after the interventions

After the completion of the structural interventions and the consolidation of the cracks with special mortar injections, the internal decorated surfaces will be restored in order to return the overall aspect.

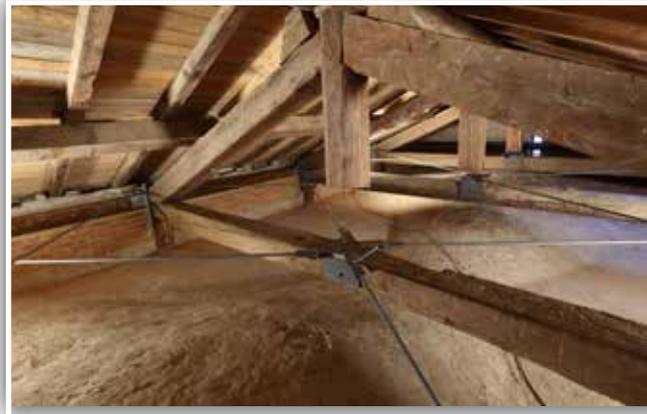
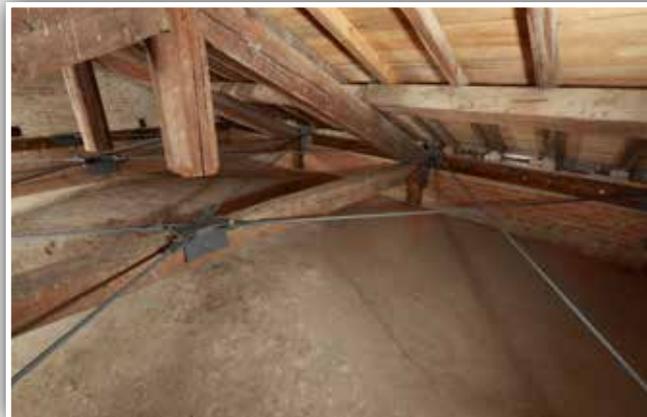
General image of the strengthening interventions on the roof over the "Scriptorium"

The material filling the sides of the vaults was accurately removed and replaced with a lighter material (to enhance the overall seismic behavior). New wooden elements were connected to the perimetral top of the walls over the corridors to create a sort of ring. The ring was interconnected with special metal joints to the existing trusses of

the roof. Thanks to these new metal elements, two couples of cross-braces were inserted just above the vaults and higher under the roof.

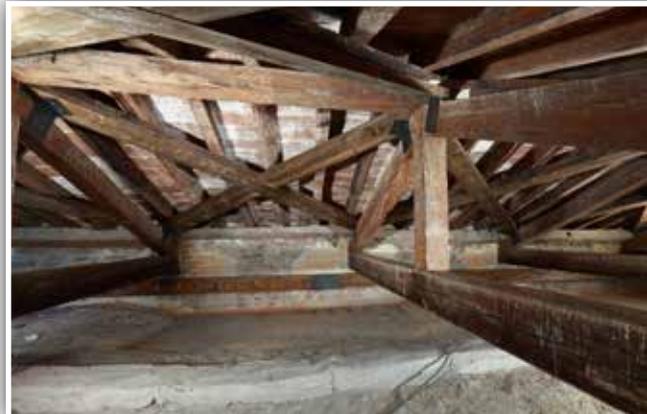
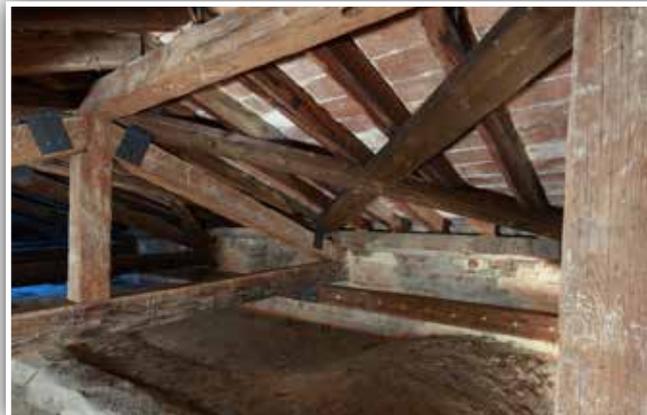
General image of the strengthening interventions on the roof over the corridor of the museum

The general aim of the intervention is to enhance the connection of the walls to acquire more stiffness and reduce the horizontal push of the vaults. As it was for the Refettorio, even for the area of the museum, the complexity of the interventions was depending on the impossibility to apply a standardized approach: in fact every joint needed to be personalized and adjusted because of the singularity of each element.

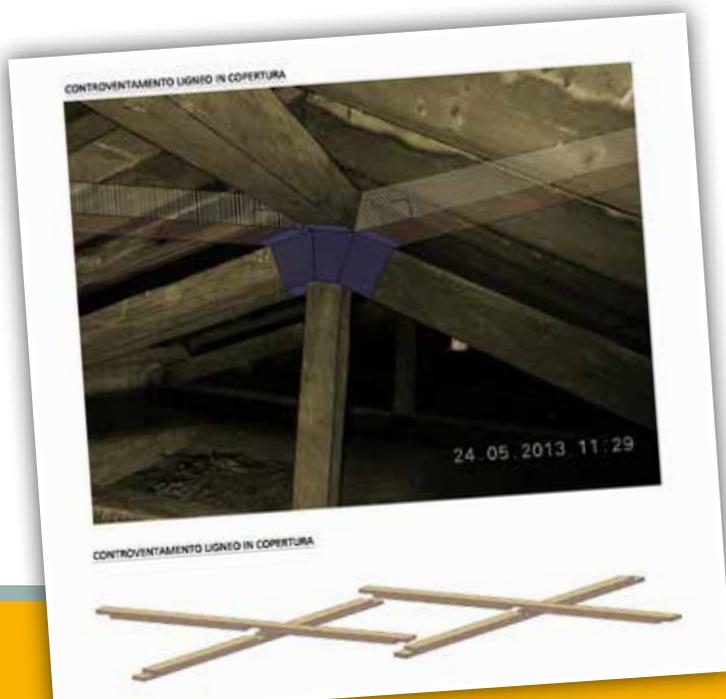
Project detail of the interventions

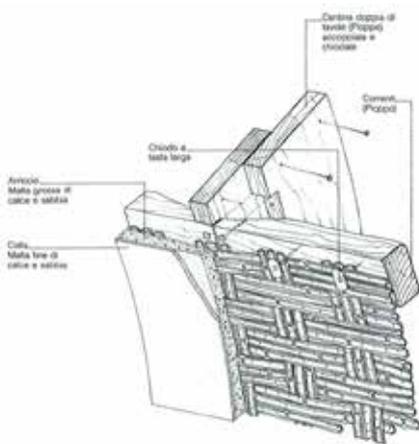
The building technique of the lightweight ceiling of the monastic library

The ceiling of the “Biblioteca Monastica” is a lightweight structure partially hanged to the upper roof trusses, made of vegetal weaved fibres supporting the decorated plaster. Such light structure has suffered heavy damages and a partial collapse after the earthquake, because of the peculiarities and weaknesses of the building technique itself. The lightweight and elastic structure of the ceiling seismically behaved differently from the heavyweight perimetral walls, thus resulting in a partial collapse and in widespread cracks. The intervention proposed consists in the realization of a wooden ring, fixed on the top of the perimetral walls and connected with the existing trusses to improve stiffness. In addition the design team proposed the insertion of a couple of new plywood trusses side by side with the existing bearing structure of the ceiling to reinforce it and connect it to the surrounding walls.

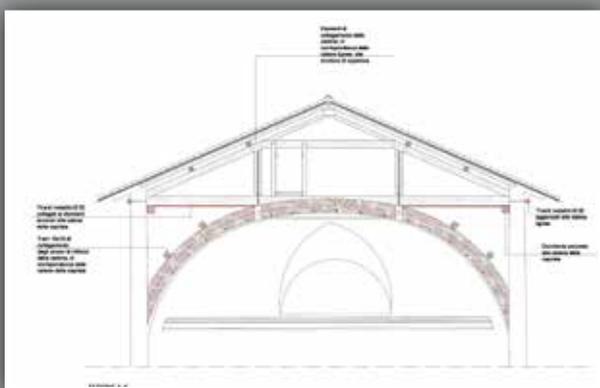
Detail of the reinforcement of the ceiling

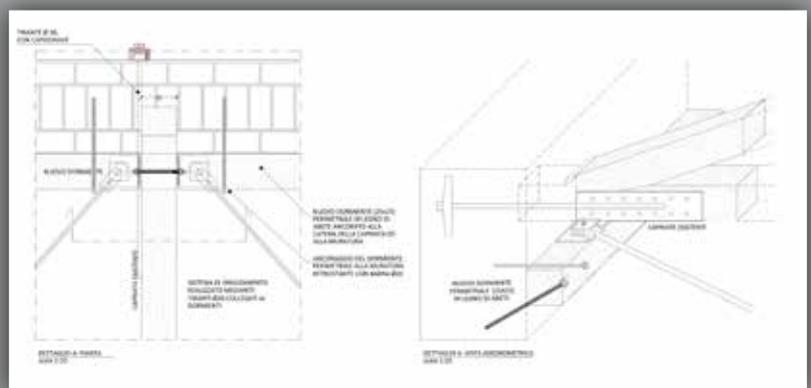
Detail of the reinforcement of the trusses sustaining the roof of the monastic library

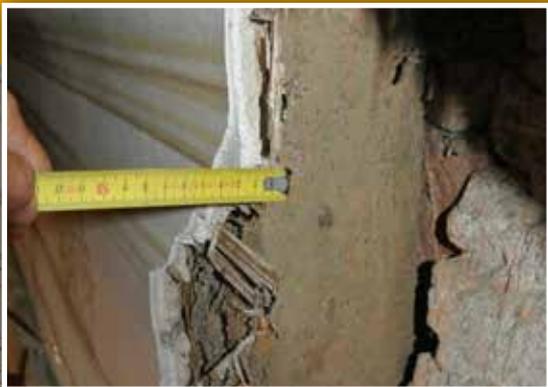
detail of a portion of ceiling collapsed during the earthquake.

After the completion of the reinforcements, the internal surfaces will be completely restored, the decorations will be cleaned and repaired and the collapsed portion – if possible – will be reinstated.

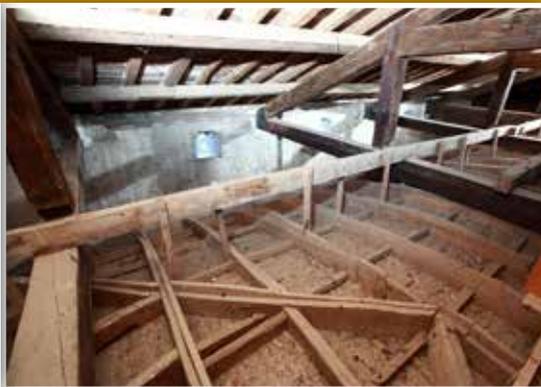
general view of the ceiling and of the structure of the roof before the interventions

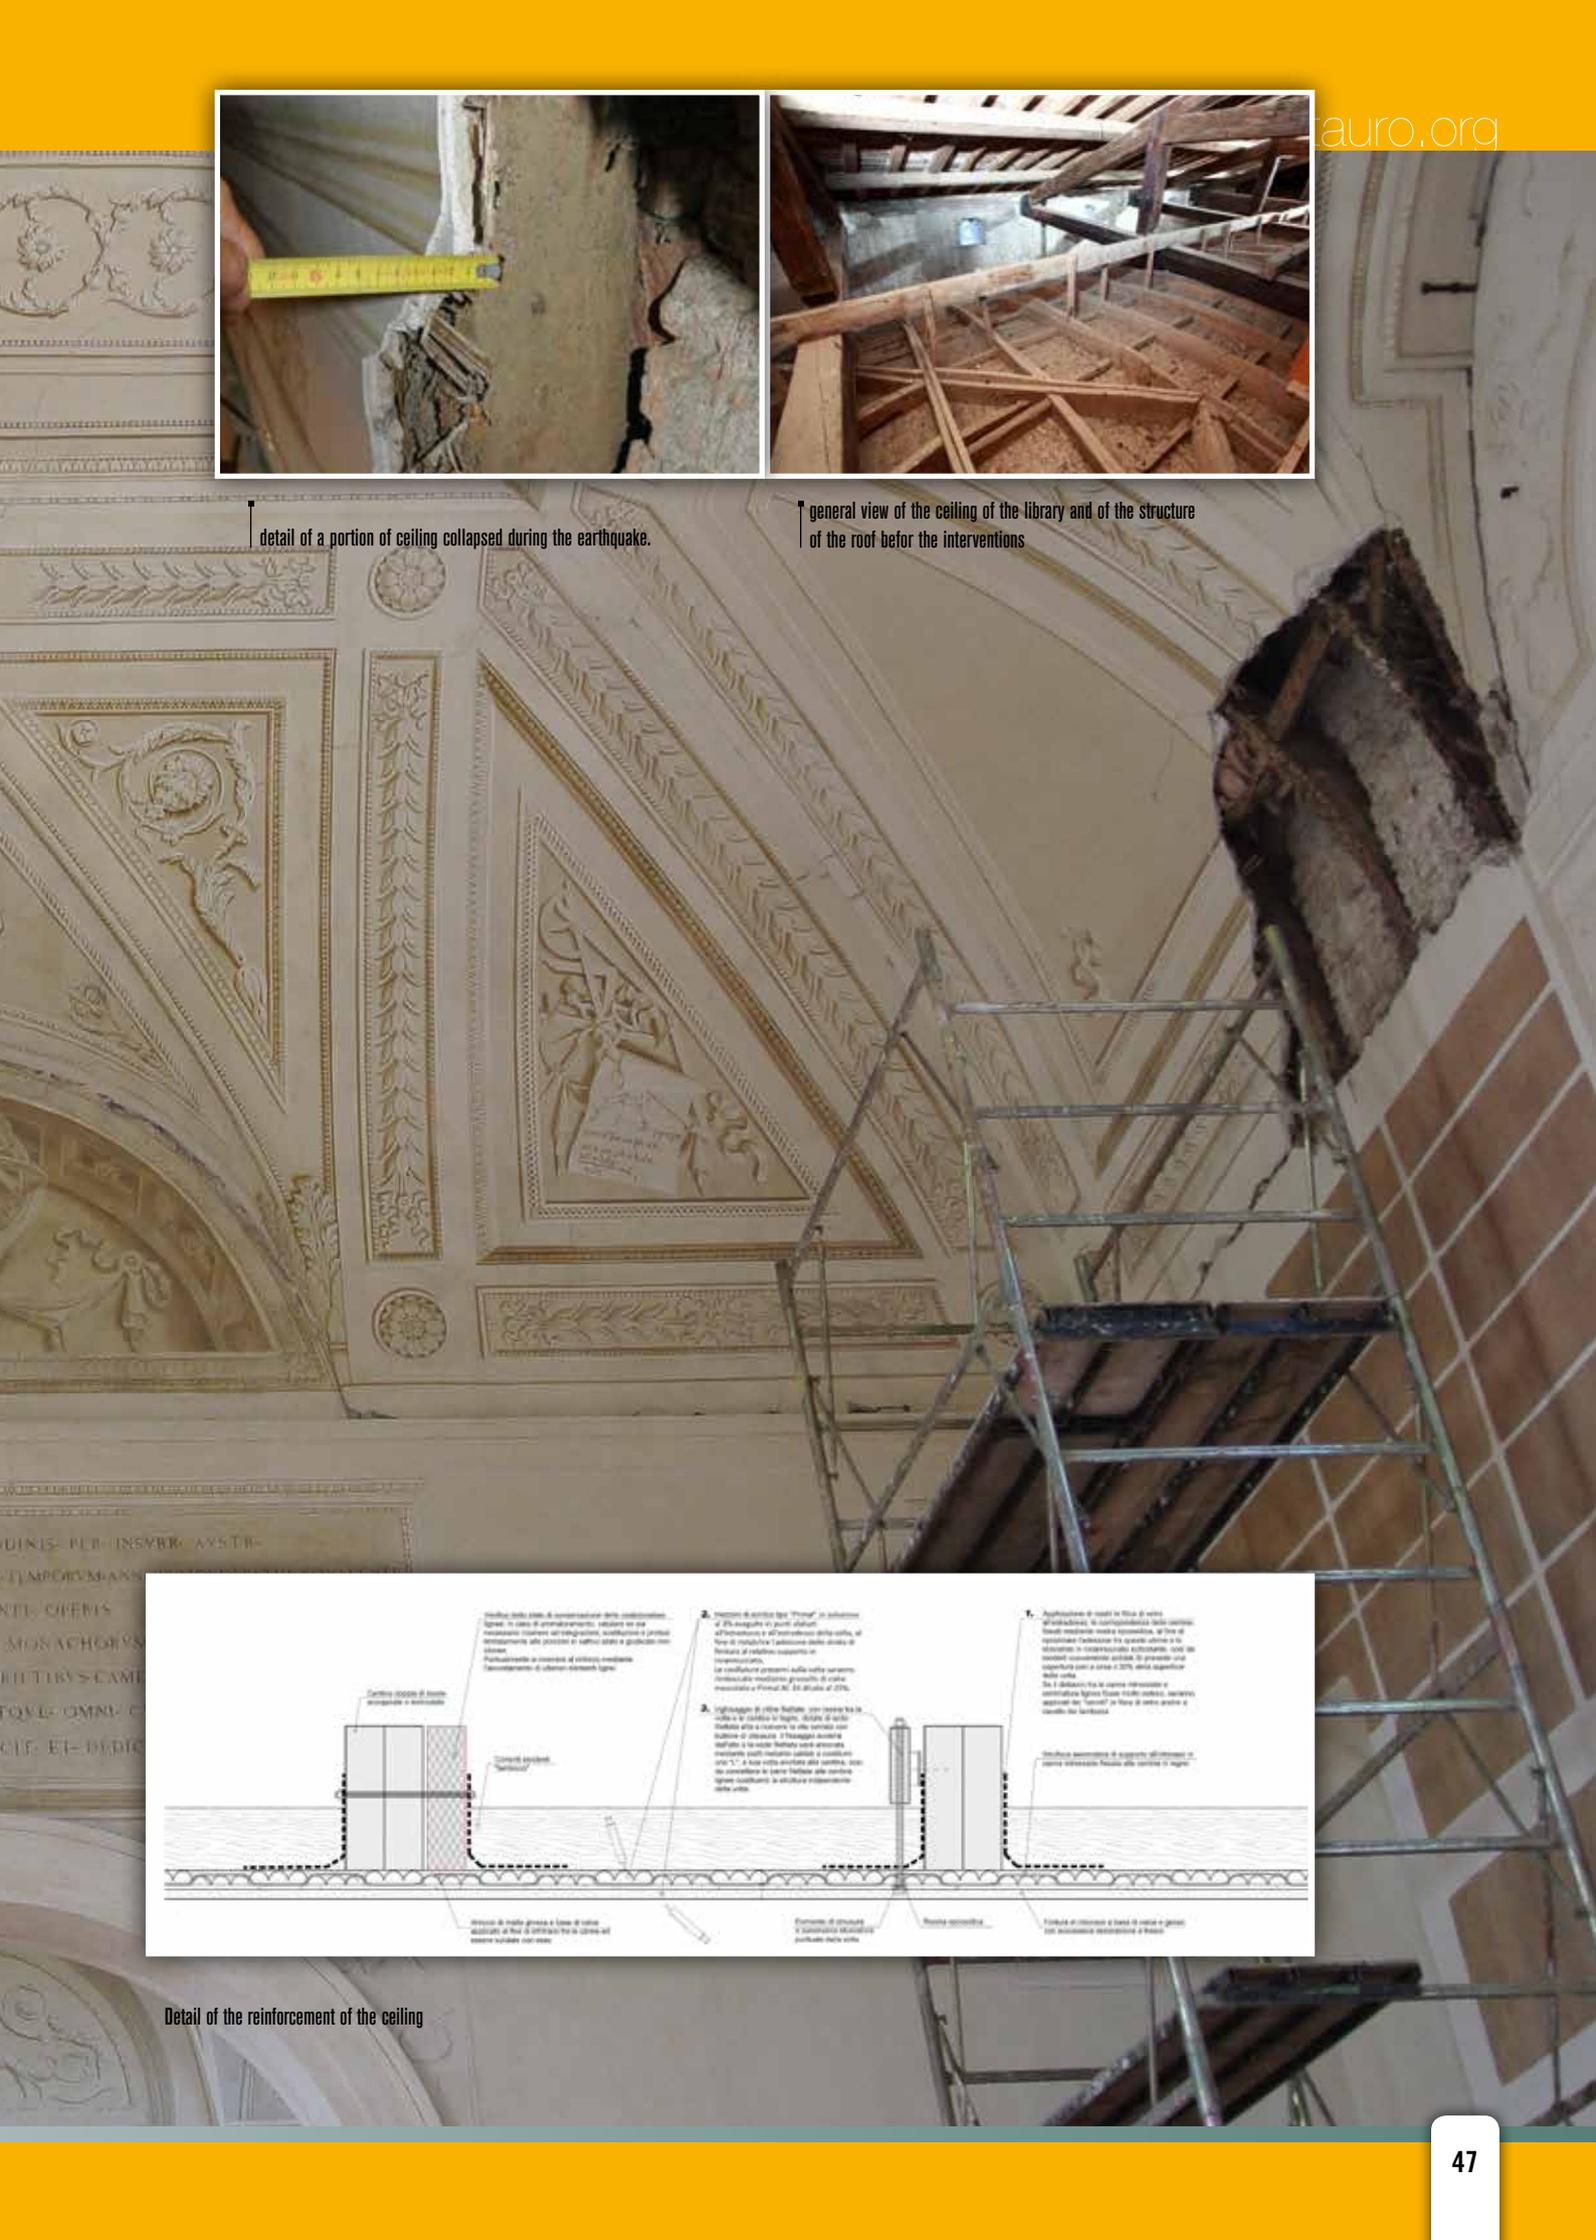
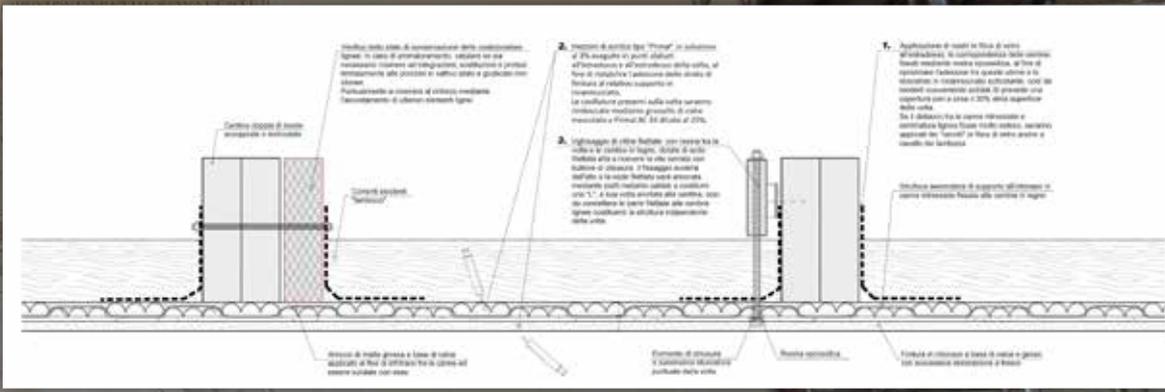
Detail of the reinforcement of the ceiling
