RESTORATION OF CULTURAL HERITAGE: TECHNIQUES AND SUSTAINABILITY

PALAZZO DELLE SCINTILLE

A connection between old Milan and the new skyscrapers city

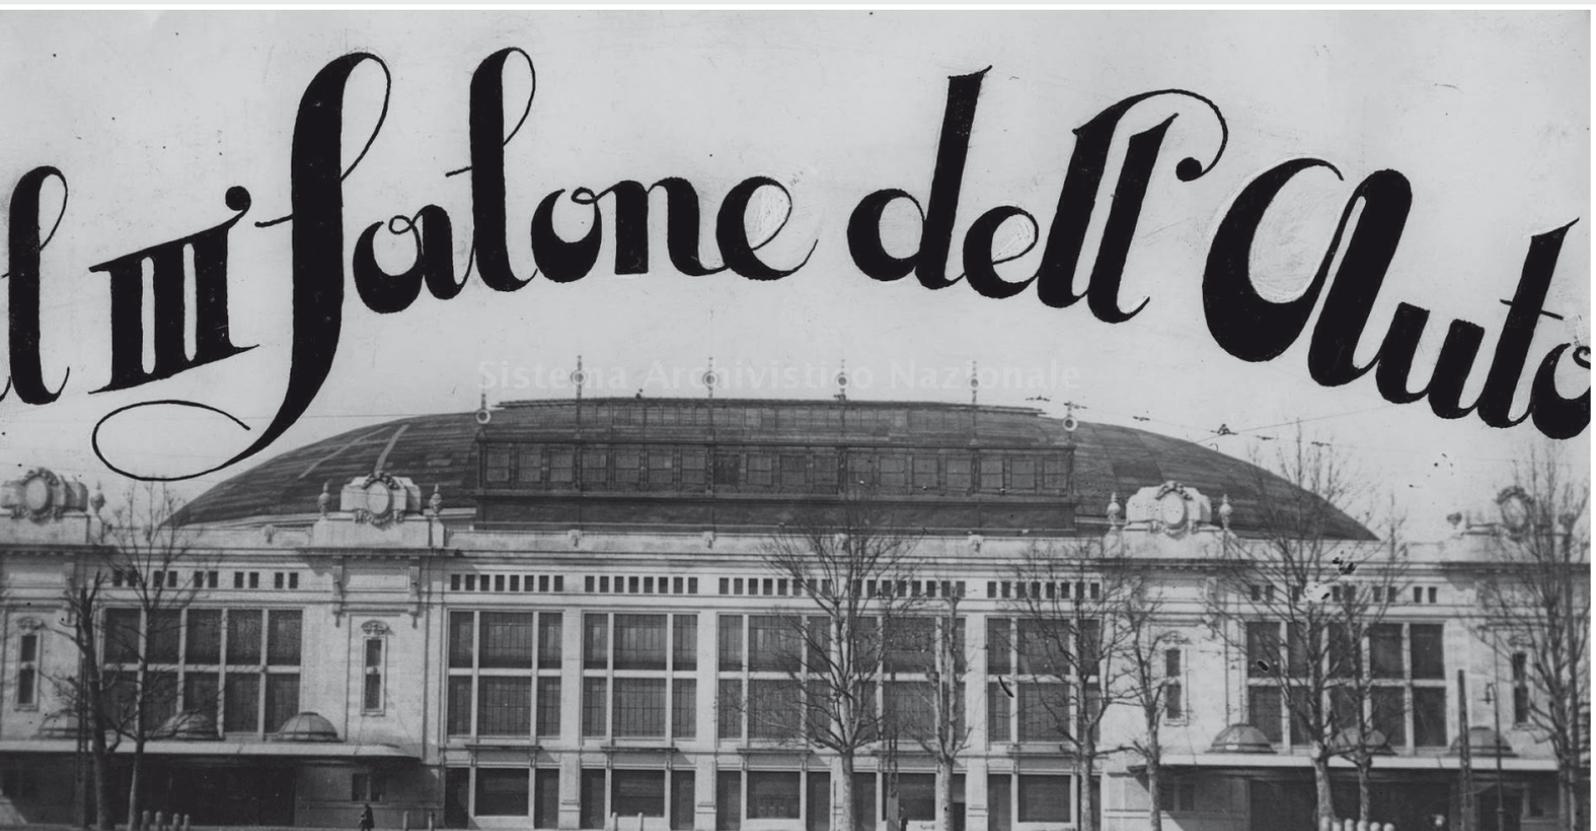
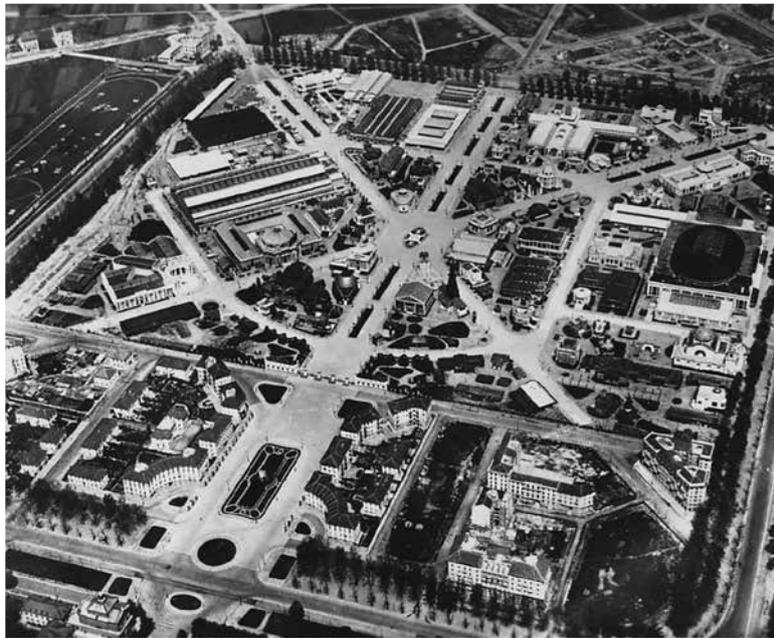
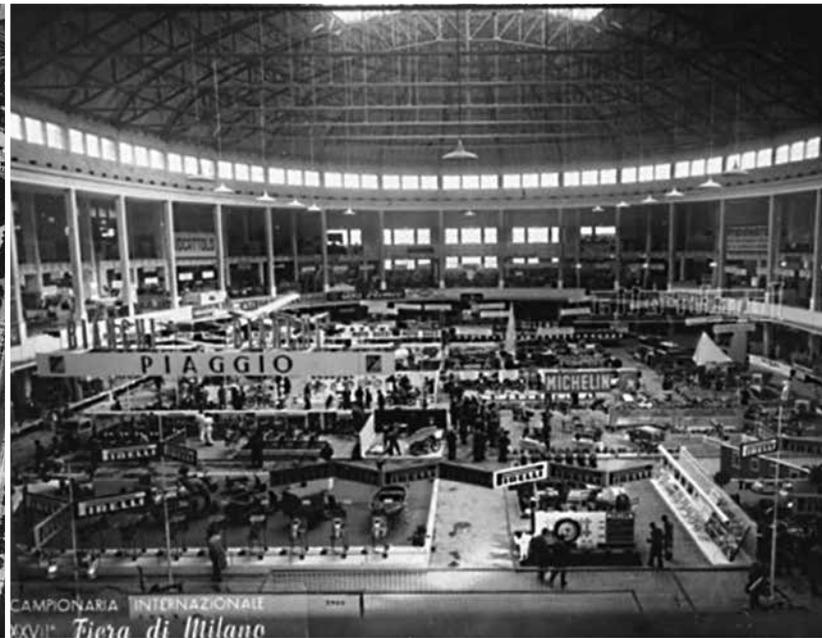
The Pavilion 3 is extended for 10.000mq on a rectangular diagram (104m x 81m with a mixed concrete-bricks structure) covered by an iron and glass dome described as an "inventive technical conception" where the iron structure was supported by a glass tambour. The dome was rebuilt after the Second World War bombing. This architecture was conceived likewise the industrial ones, based on a rigid structural grid softened with decorative cement items. Those reshaped classical forms into charming Art Nouveau tested elements. Facades were designed to be symmetrical, where windows scan a regular lands and grooves play. The interior was planned by the architect Paolo Vietti Violi to be a mul-

tifunctional space, a big empty room adaptable as showroom, racetrack but also concert and conference hall. It was a modern space, comparable to major expo spaces around the world (Paris, London, New York) shaped full-height by a ring of slender béton fretté pillars (9,50m height and 0,50m diameter).

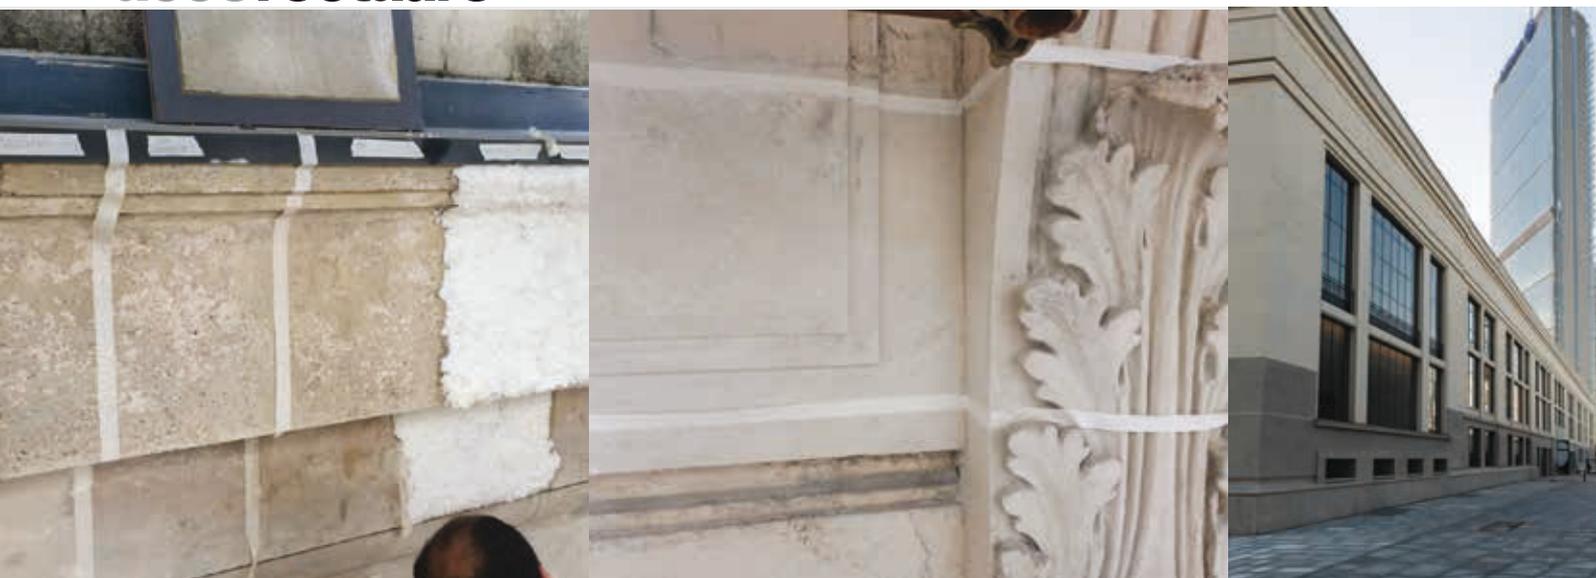
After this preliminary study the project has been developed to answer the building damage necessities, most of whom produced by anthropic activities. The different facades presented more or less the same decay typologies and a general surface degradation with deposit, biological colonization, efflorescence, staining and soiling due to metal components

presence, but also hair-crack on finishing cement plaster layer, improper grouts operations or scratches. Decorative elements have been frequently subject to missing part and disgregation, which compromised the original shapes recognizability, added to this an ochre acrylic paint had been laid out in the recent past and has quickly formed a film, boosting the decay situation. The West front presents also stains and spurts caused by bitumen application on the surfaces and degradations are marked by addition and demolition operations. In the same way fronts South and North present signs of improper anthropic action that led to a strong presence of decaying structures, loss of modeled parts and irregular grouts or shaves.

In order to begin effectively the restoration, all the past additions have been removed starting cleaning operations, articulated into three accuracy levels:

1. Plasters typing, which needed bandages using acrylic resin or animal glue and overrun micro and macro flora removal by the application of a selective action exterminator;
2. Salt extraction through compress, deposit and paint removal by using a elicoidal micro air abrasion cleaning system assisted with manual dry-cleaning;
3. Chemical cleaning by reagent application through pad or brush for oxides removal and through compress for oil, paint and wax.

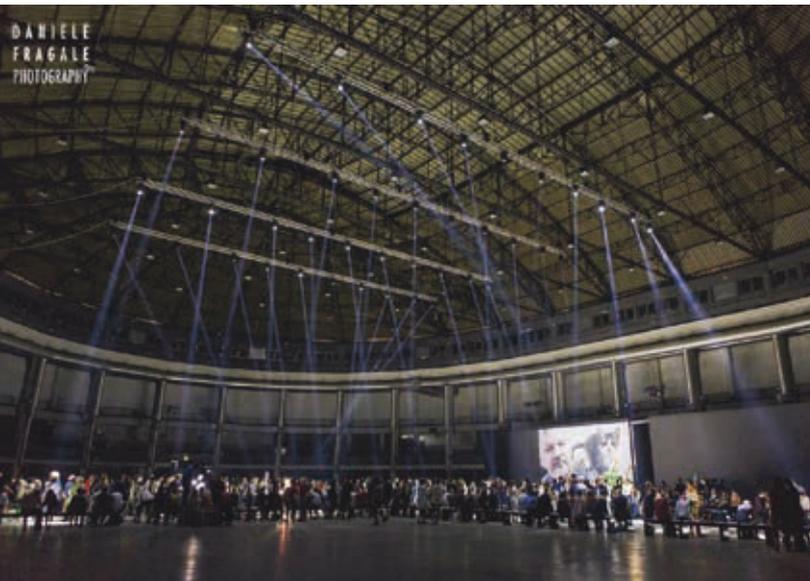
The next steps of the restoration project envisaged the surfaces consolidation using ethyl silicate, applied by brush or by pad, and consolidating injection if necessary. Those preliminary proceedings have allowed the conclusive operations: material loss reintegration with compatible mortar and plaster, hair-cracks grout and decorative missing parts replacement with off-site realized new elements. New ones are characterized by a topcoat comparable to the existing finishing layer, made recognizable shaping them as simple volumes. A parallel project has involved the iron window frames which present a heterogeneous state of conservation, those have been restored or replaced with identical ones. To guarantee natural micro-ventilation and prevent the detachment phenomena acceleration the creation of specific splits have been made in proximity to lower and higher elements.
