THE CONSERVATION OF PONTE DELL'ACCADEMIA IN VENICE

How to maintain the historical appearance with updated technologies

Tan Roushuang

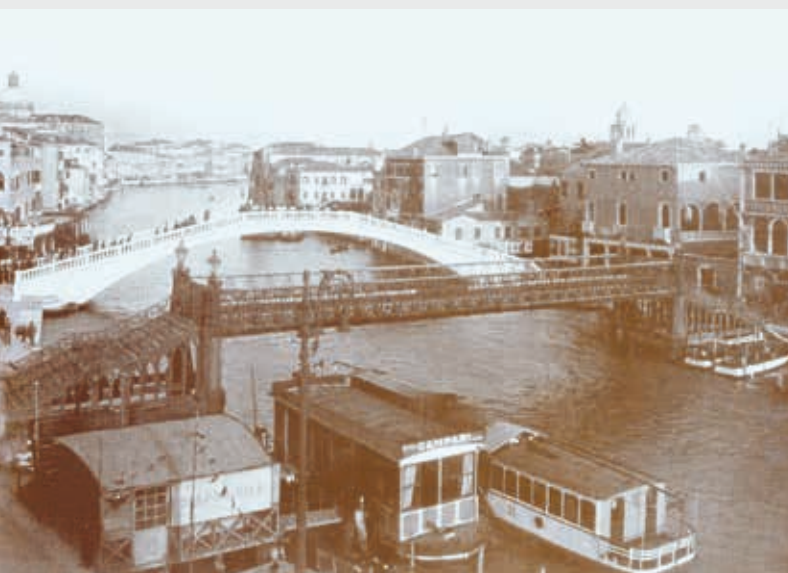
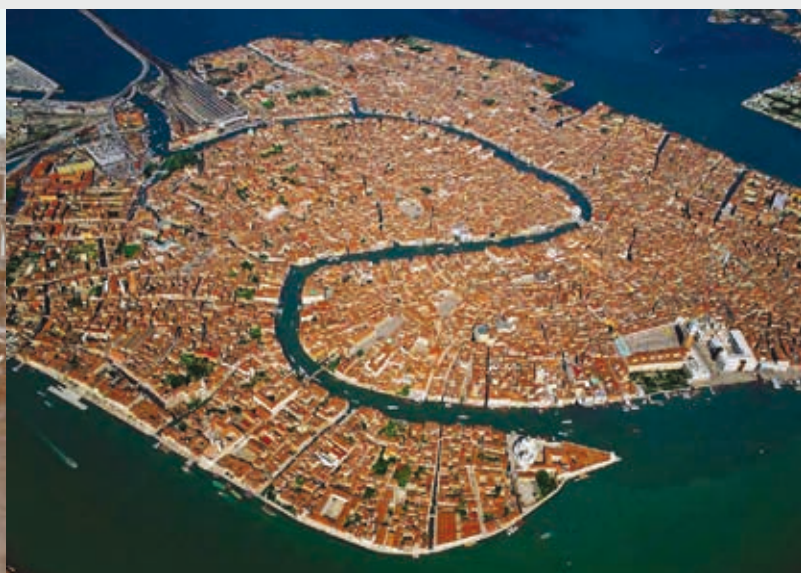
The principle structure consists with two Metallica arch supported by brick stacks sit on each side of the canal. The span of the both arches is around 50 meters, and the height from arch top to water is about 7 meters. Between the arches locates a metal wind resist system, it works side by side with the arches forming a solid base, on which a wooden structure of steps and platforms has been built.

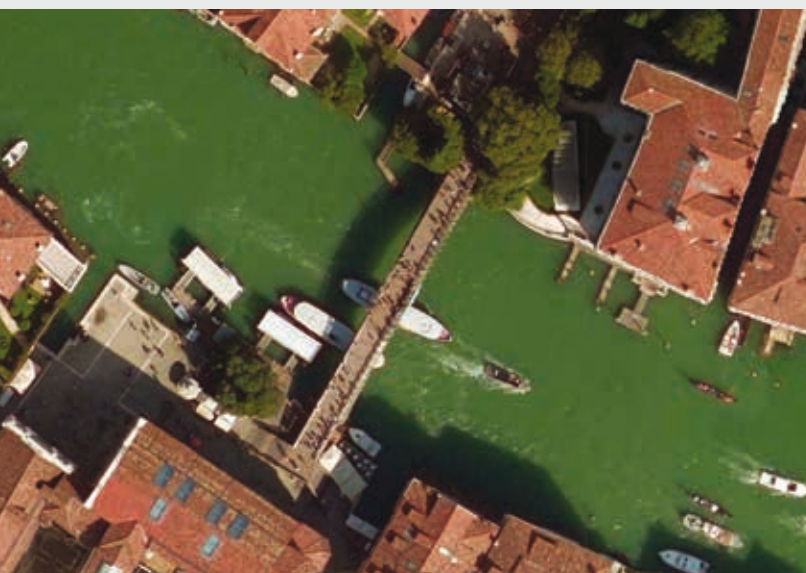
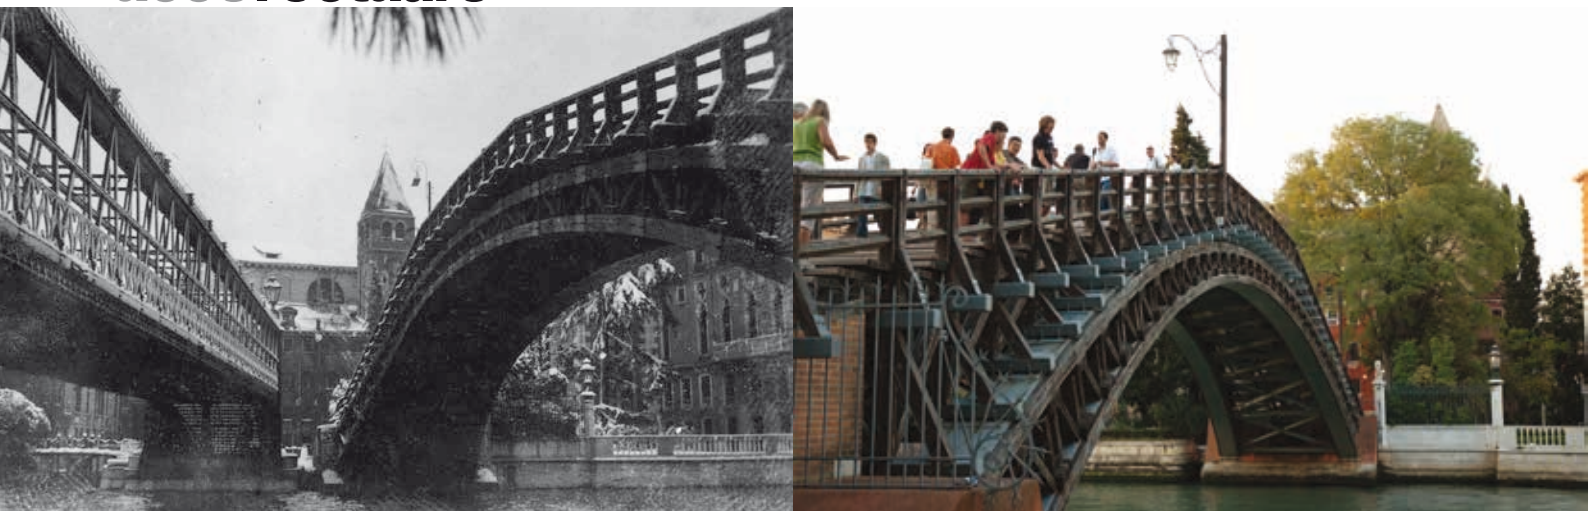
The foremost outcomes of the sampling study are listed as following: the most evident decay is the corruption of wooden components especially those function as coating, contacting directly with metallic materials. The stagnated sea water without being efficiently ventilated is the key factor that exacerbates the deterioration of the wood; However, the most critical damage concerns the rusting of metallic components, which occurs most frequently also on the joints where the various materials meet. For instance, the steel profiles with a C section, coated with larch panels, are the most essential structural elements of the two arches with a span of 50 meters that bear all the load of the upper structure. The sea water enters the gap between wood and steel frequently, due to its concealed

position, the serious corrosion of steel revealed only after the demolition of wood during the sampling study. The concealment of degradation increases tremendously the level of potential structural risks. Another unignorable phenomenon is the sever abrasion of the wooden steps and platforms cause by the daily traverse of outrageous number of tourists.
