A Restoration Story  
**Şeyh Süleyman Masjid**  
(Turkey-Italy Collaboration of Restoration Approach)

Şeyh Süleyman Mescidi Restorasyonu ve Eğitim Projesi  
*Restoration of Şeyh Süleyman Masjidi and Training Project*

Architectural Approach and  
Design of the Restoration Project of  
**The Şeyh Süleyman Masjid**

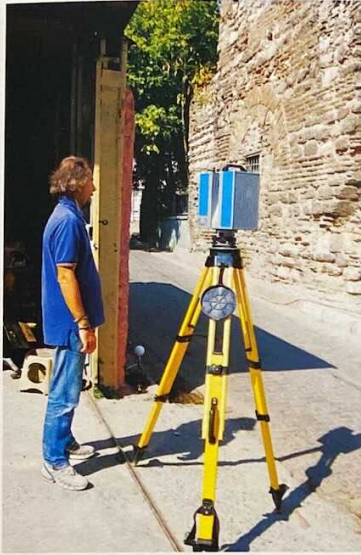
Figure 1.  
Photogrammetric drawings of the building.

1- Repreparation of previous projects in terms of photogrammetry which had some measurement mistakes (Figure 1).

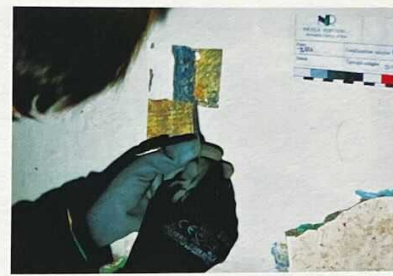
Figure 3a-3b.  
Site works before the laboratory examinations.

3- All the layers of the building (frescoes, plaster, wall ect.) were observed typologically and chronologically by taking samples. The mentioned examinations were carried out in the laboratories in Italy (Figure 3a-3b).

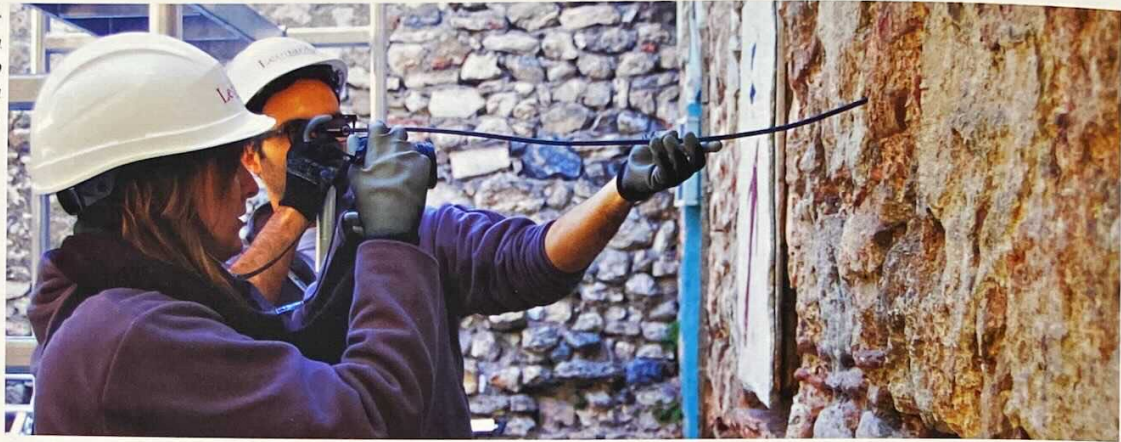
Figure 4.  
Examination  
of the micro  
cracks with  
camera.

4- Interpretation of the cracks, gaps and materials to define the structural problems (Figure 4).

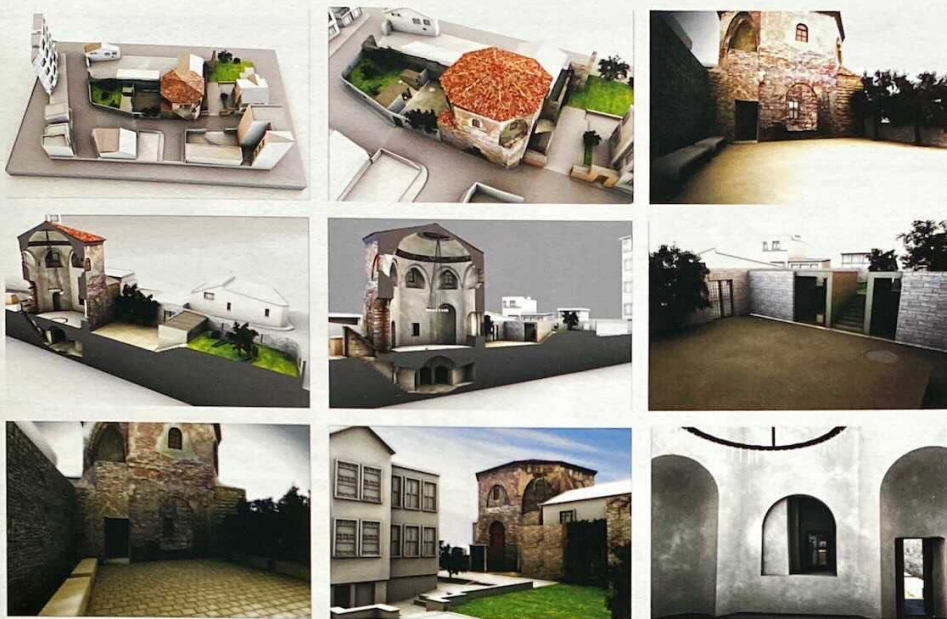
Figure 6.  
3D modellings of  
the building.

Using the laser scanning technology, a 3D model of the building was created in which every detail of the building either interior or exterior could be seen (Figure 6). Sections of several axes could be examined. Depending on the information got from those data, analytical survey drawings were detailed (Figure 7). Having benefits of this sort of method, documenting of historical buildings were revised and detailing of 2D documents in relation with 3D drawings were discussed. It is stated that current projection systems and tender documentation need to be improved accordingly.

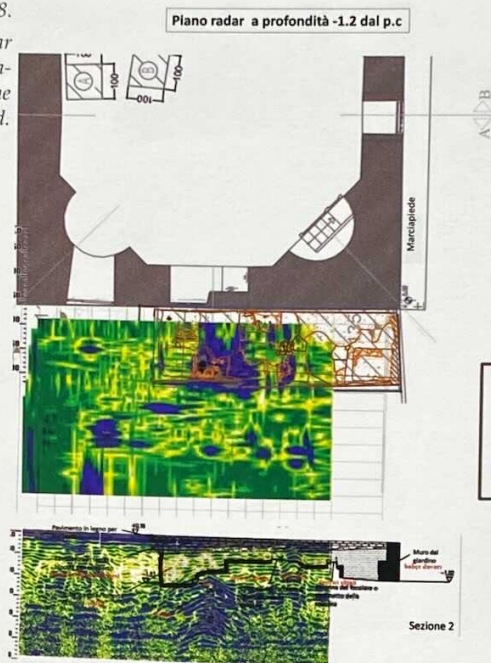
Figure 8.  
The geo-radar  
implementations in the  
courtyard.

During the radar implementations, an archaeological area of 4 m x 7,5 m was discovered in the courtyard of the masjid (Figure 8). The loca-

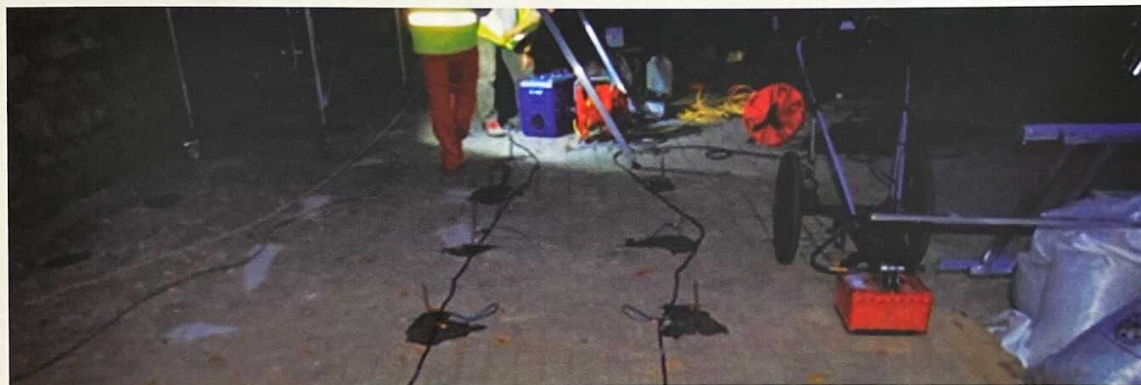
Figure 10.  
 ERT implementation surrounding the building.

The electrical tomography implementation (ERT) showed that the foundations of the building are positioned 4 m below the ground level (Figure 10). It was understood that the water storage under the crypt was carved into the rock. Also the existence of the archeological area in the courtyard was determined by ERT. The data of ERT and radar confirmed each other on this issue.

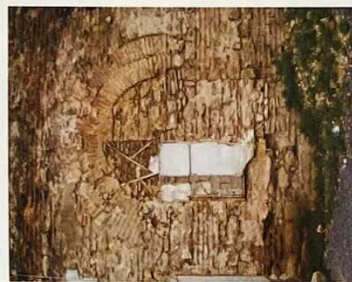
Figure 14. Exterior view of the niche which the original entrance is positioned.

Since it was understood that the previously mentioned annexes belong to the Ottoman Era depending on the historical researches and material analyses, the restoration project in which the annexes are protected (the existing entrances and windows) were revised (Figure 14).

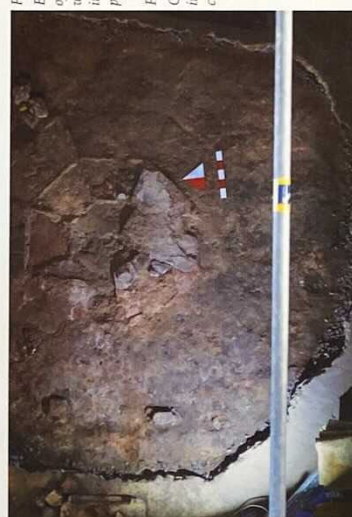
Figure 15. Original flooring plan of the central hall.

After removing the concrete floor covering in the masjid, the surviving original Byzantine flooring, which did not seem in good condition was revealed. It was reported by archeologist Zanmi that, this original and octagonal planned flooring had been designed as a central hall in

order to reach the water necessary for the baptism. The area was cleaned and protected originally. The relation of this octagonal scheme with the crypta could not be explained. The crypta (grave), which had stayed closed before the restoration, was designed to be visited by protecting the original interior features after the restoration (Figure 15).

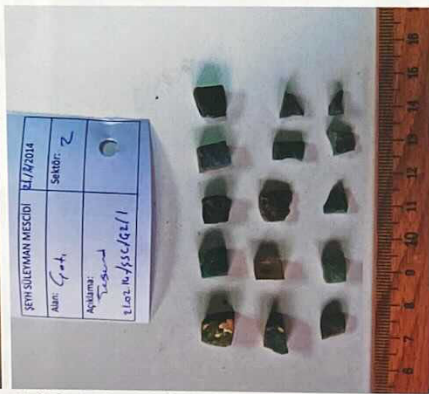
Figure 19.  
The tessera  
pieces of the  
dome filling.

In the Ottoman Era, the dome was filled and arised (Figure 19-10), thus the building had a new elevation. The building had modifications in accordance with a tekke first-

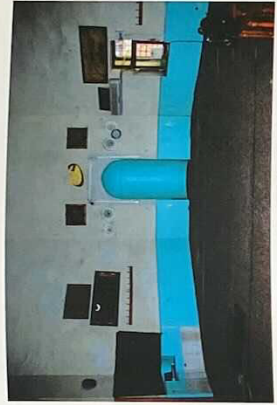
Figure 21-22.  
View of the  
walls before  
restoration and  
after scraping.

A new abluion place was built as a later addition. A concrete wall was built in the latest 50 years instead of a wall constructed with rubble stones which could be seen on old photographs

(on left hand side). Furthermore, the windows were placed with concrete frames. During the restoration period, the mentioned wall was rebuilt in original style (Figure 23-24-25).

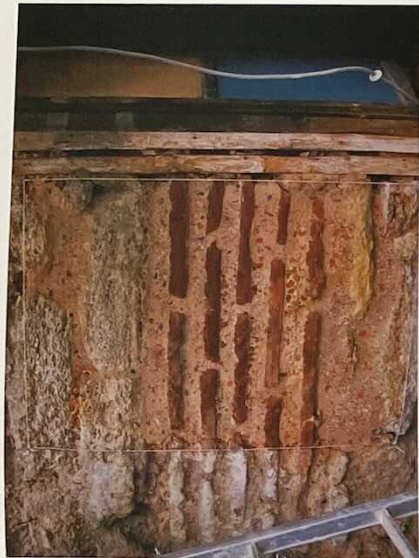
Figure 27-28.  
Detailed views of the surfaces (Before the restoration and after the simple implementation).

In order to understand the need of the building and to define the construction steps, the surfaces should be observed very well. The saying 'To know is to conserve' could be a slogan which summarizes this period.

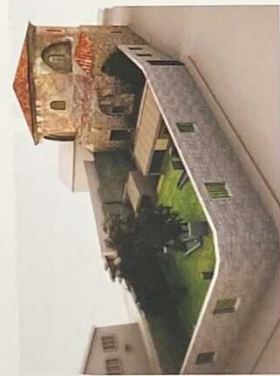
Figure 29a-29b.  
The model of the building before restoration and view after restoration.

As mentioned in this essay and understood from the projects and charts of the essay, there is a collaboration of all experts and support of Med Art behind the great success of the project. Each information on the project has been reached by the experts and as seen from the graphics, a sort of x-ray view of the building has been created (Figure 27-28). The texture of rubble wall was not indicated by the AutoCAD hatch commands, instead they totally indicate the real texture composition of the building. They have been formed depending on the physical observation and survey methods (Figure 29a-29b).

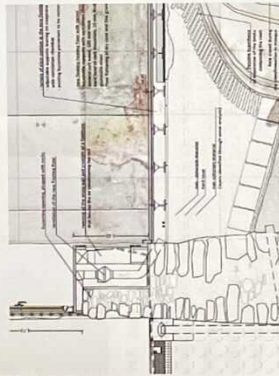
Figure 30-31.  
Raised flooring project and implementation.

Approaches on energy saving should be another focus of a modern current restoration project. A demountable platform was designed in order to install the heating system for this building by using raised flooring (Figure 30-31). Although exhibition of original Byzantine flooring was proposed underneath the raised floor, it could not be realized because of the size of the room, thus the original flooring was left underneath covered. As for the lighting of the interiors, an optional LED system was proposed to lighten the dome effectively (Figure 32-33).
