Nicola Berlucchi

studio
Berlucchi
società di ingegneria
dal 1920

RESTORATION AND TECHNOLOGIC ADAPTATION OF TEATRO SOCIALE DI BERGAMO

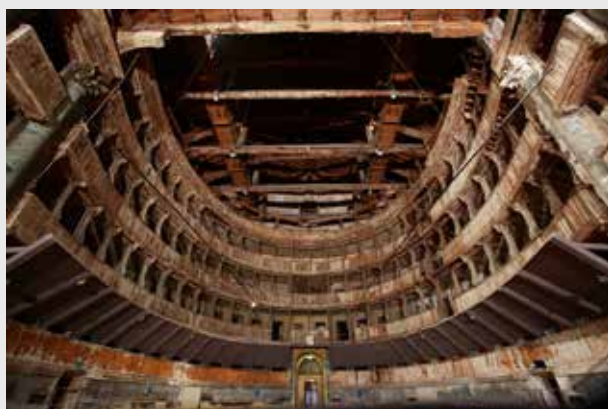
The main hall of the theater and the wooden parapet of the boxes before the beginning of the restoration. The advanced state of degradation can easily be noticed.

Before the re-opening of the building yard (2008), the architecture of the theater was in a very advanced state of degradation: the rows of boxes, were unsafe for the neglect of the time and inaccessible for any use; the area of the audience and the rooms of the theater had undergone rearrangements and did not meet any current standards.

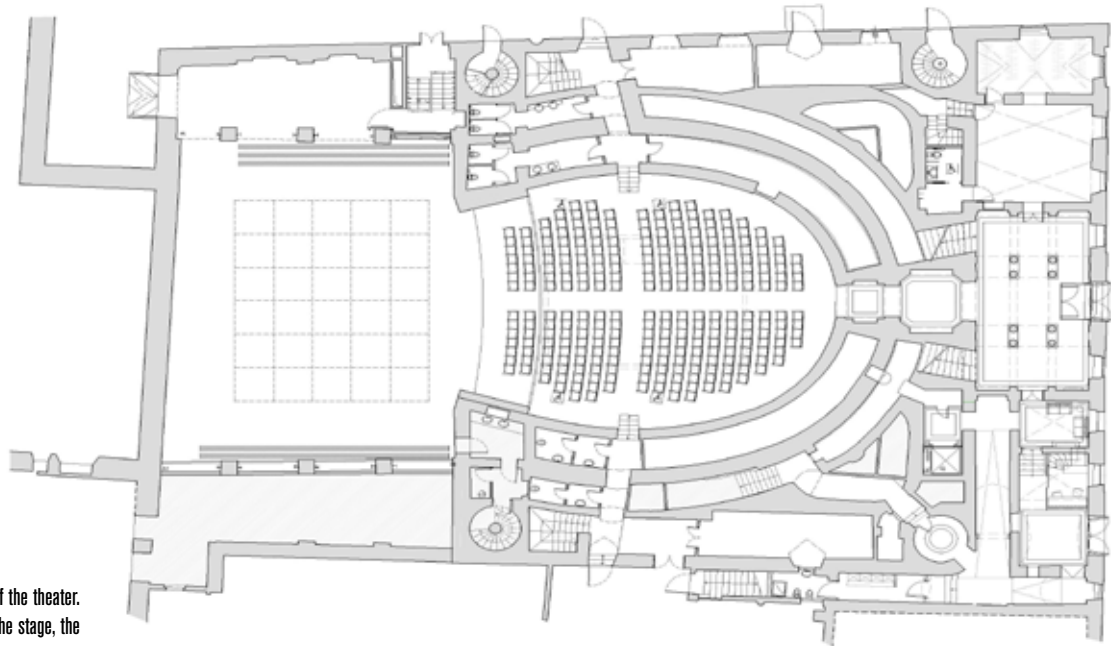
The ground floor of the theater.
From the left to the right: the stage, the
main hall and the entrance area

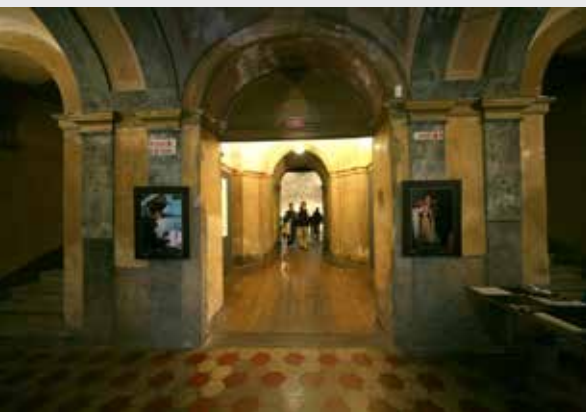
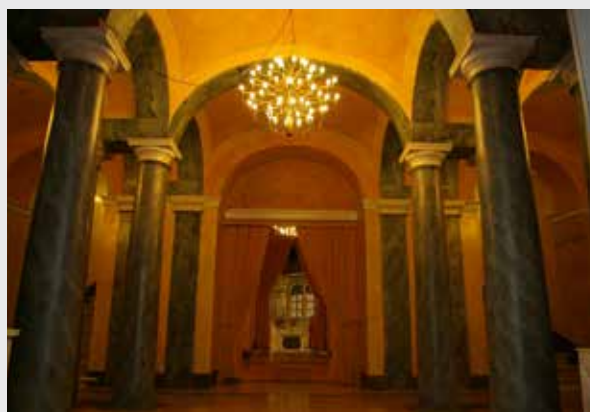
The entrance foyer of the theater before
and after the restoration.

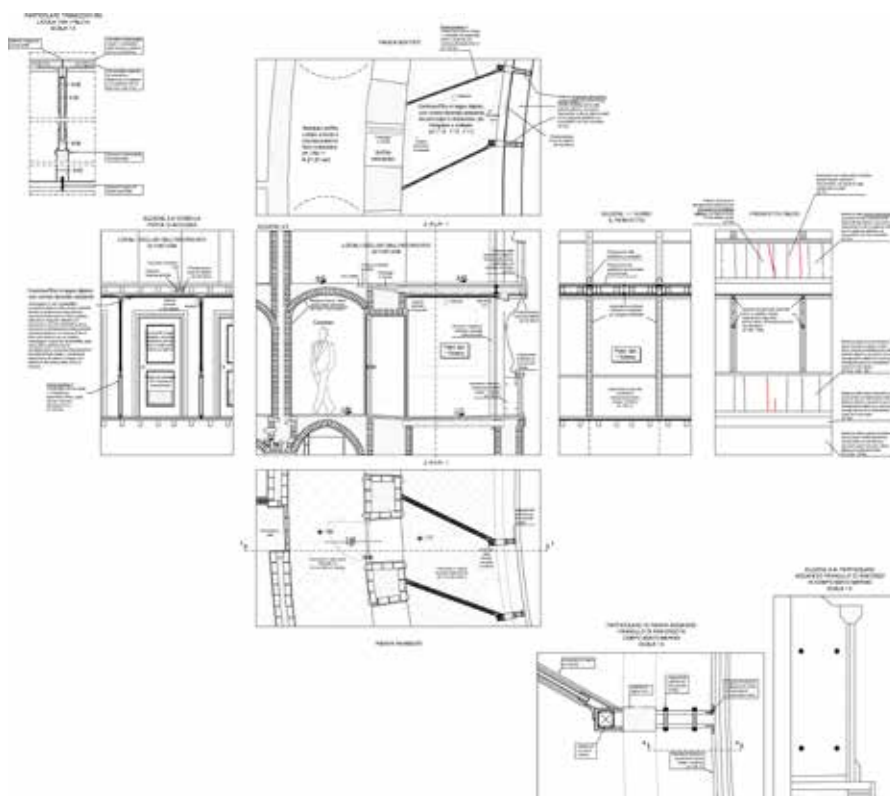
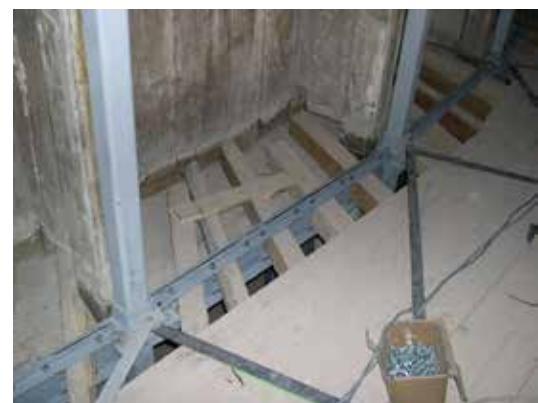
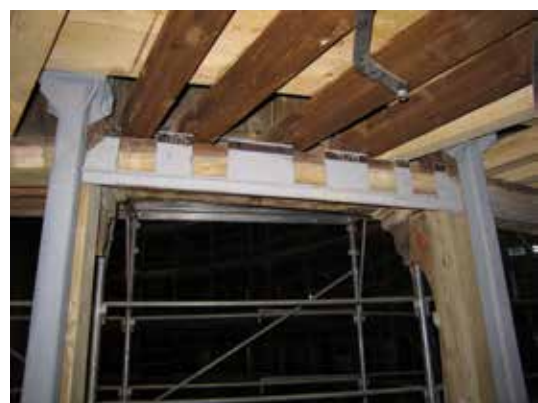
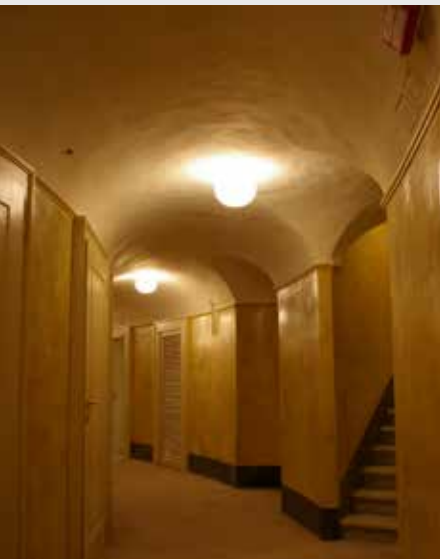
A schematic drawing of the air-flows in the main hall and on the stage.
The technical areas of the air-conditioning system that host the main treatment units
The corridor of the boxes used as an air duct (plenum)

The design-idea that made it possible to reuse the old theater has been to employ each perimeter corridor that connect the boxes as an air ducts for the air conditioning system (plenum). This ensures proper cooling of the audience and of the different rows of boxes, without the need for bulky and intrusive pipes that would have distorted the historical walls of the building.

The air distribution in the volume of the stage and of the fly loft is designed to counteract the typical hot rising air currents and to avoid interference with the scenes, which could cause fluctuations: in fact, the air is fed from above and took back from the floor of the stage.

Even the boxes and the stalls area are, like the stage, a difficult volume to be air conditioned: the elevated height of the stalls-room causes the thermal stratification and the limited interstory heights of the boxes make it difficult to realize a branched fluid distribution. That's why the volume has been divided into two main areas: the stalls and boxes. The latter are conditioned by the air that is placed above the gallery, and that is taken inside the boxes in a different way for each row of boxes. Instead of realizing metallic air ducts, the perimeter corridors that connect the rear stages have been exploited as return air ducts for air conditioning system (plenum). The temperature of the first level is controlled independently from that of the second and the third, which are higher and therefore subject to the effect of rising hot air, to prevent their over-heating. The audience, which is located at a lower level, is served by an air distribution system installed on the floor, thus ensuring low input speed and a widespread distribution. The separation of air the stage from the main-room also allows to make "neutral" the orchestra pit, thus avoiding any air currents particularly troublesome for musicians.

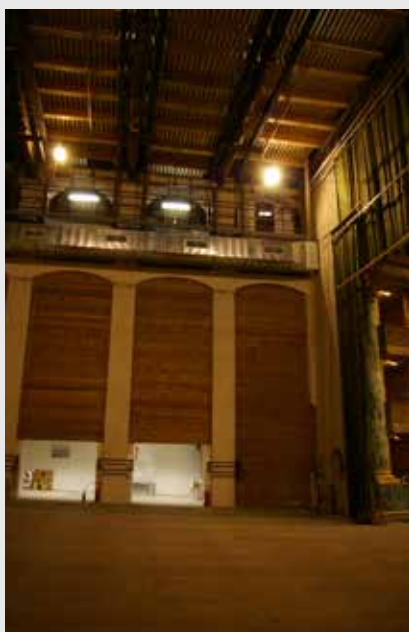
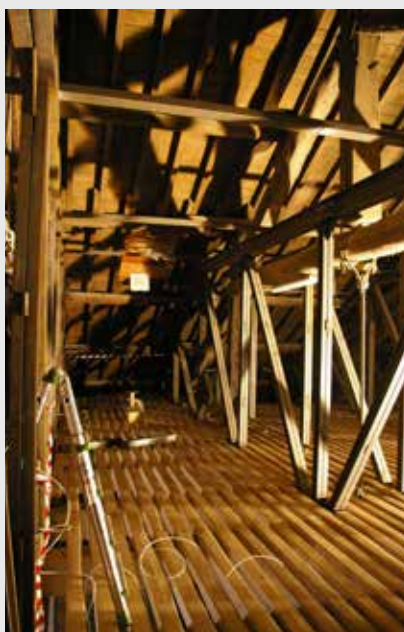
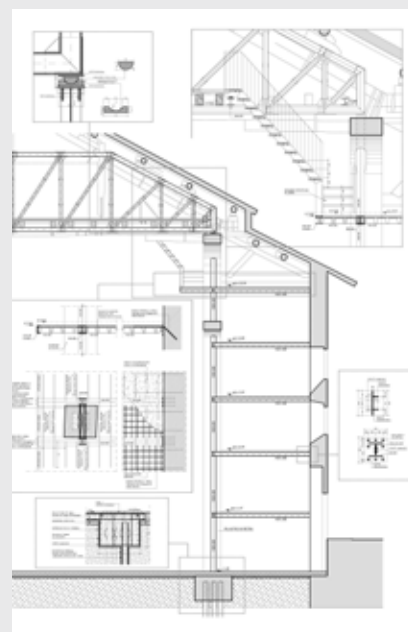
On the left, the new stage and the area of the new dressing rooms.

In the center, the new wooden fly system and the steel trusses that supports it. On the right, a technical drawing of the area of the stage and the dressing rooms.

To guarantee the correct functioning of the "theatrical machine", a new fly system has been built above the stage and new dressing rooms were inserted in the existing space on the side of the stage. Such needs have prompted a massive intervention of structural consolidation of the trusses, which were complemented by new composite steel-trusses, to support the huge loads of the fly system and scenes (over 130,000 kg of steel added); everything has been supported by a "surgical" intervention made with steel elements, side by side to old brick pillars, based on new foundations with concrete micro-poles.

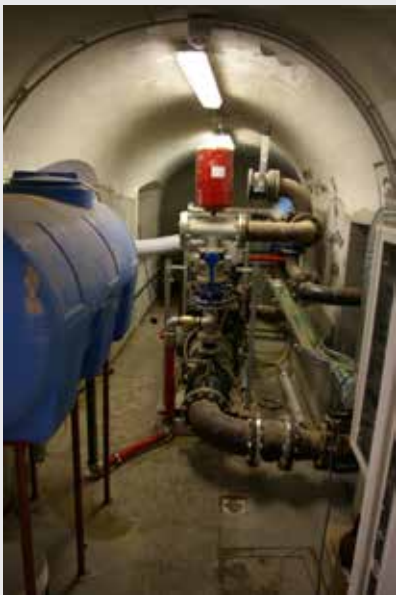
The room in the basement that hosts the main pump of the water sprinkler system

The occurrence of a violent phenomenon as a fire requires the presence of extinguishing systems. The areas with wooden structures (boxes and roof) are protected by an automatic extinguishing system (water sprinkler) and throughout the theater are installed adequate fire, fed by the water stored in a special tank realized under the stalls (100,000 liters), again avoiding to steal precious space to the theater.

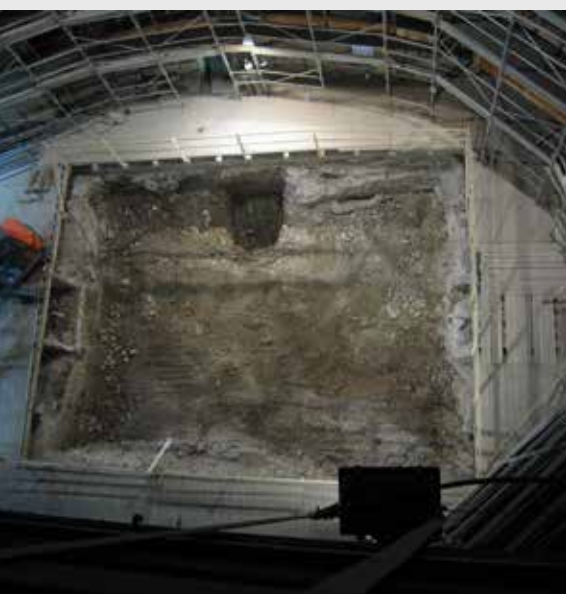
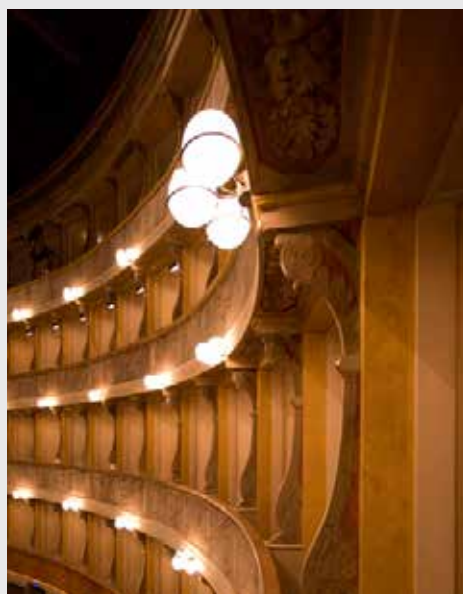
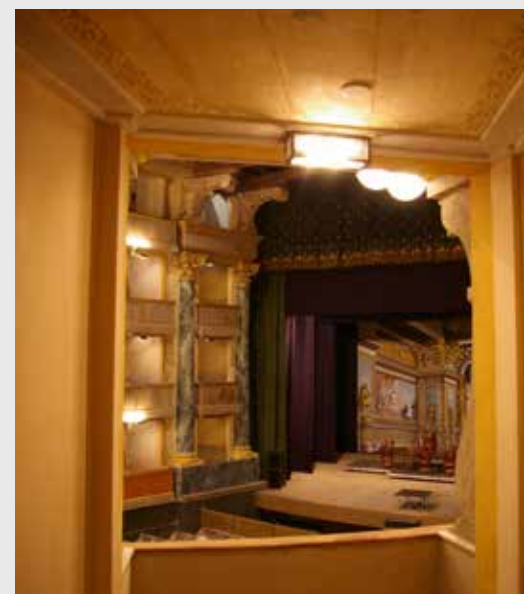
Different types of lighting devices installed in accordance with the materials, with the colors and the function of the areas

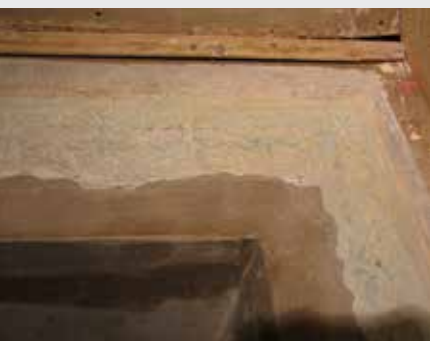
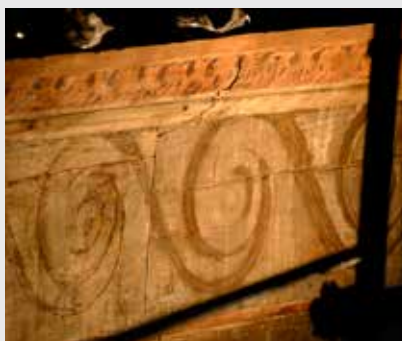
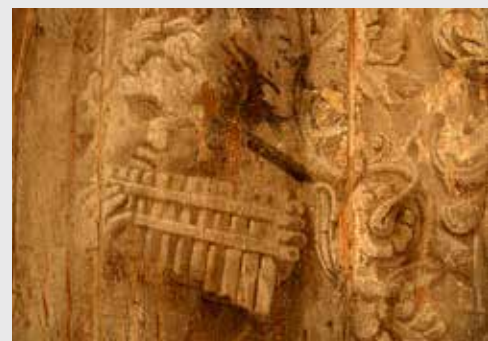
The layers of decorations
discovered under the superficial
layer of paint

Through these studies it was possible to reconstruct the pictorial layers that were superimposed during the different periods of life of the theater and create a reliable frame of the historical phases of intervention on decorations.
